THE BRYGGEN PAPERS

MAIN SERIES · VOL 3

THE BUILDINGS AT BRYGGEN
THEIR TOPOGRAPHICAL AND CHRONOLOGICAL DEVELOPMENT

Asbjørn E. Herteig

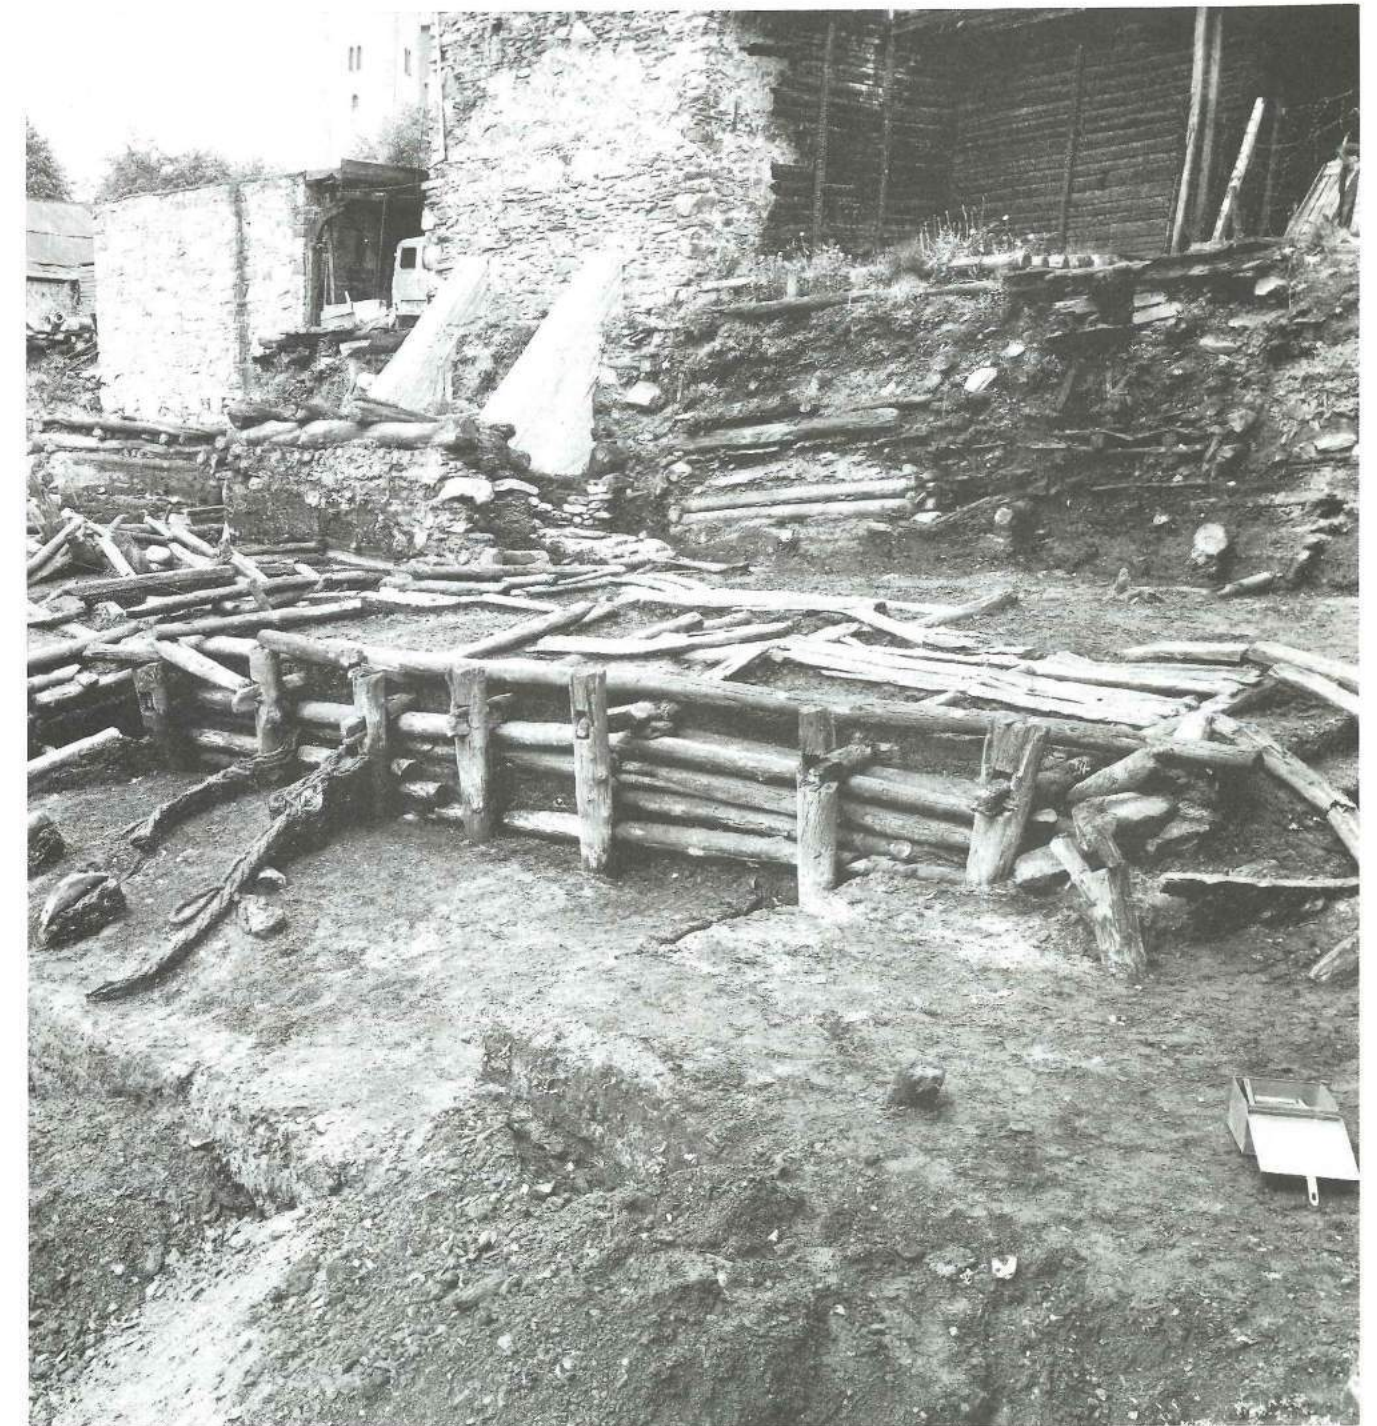
Fig. 2. The excavated remains of the wharf in Bugården South, destroyed in Fire VI (1198).

level at the very front. Its use as a wharf was clearly demonstrated by the presence of hawsers several metres in length still fastened to the front posts (cf figs 2 and 26).

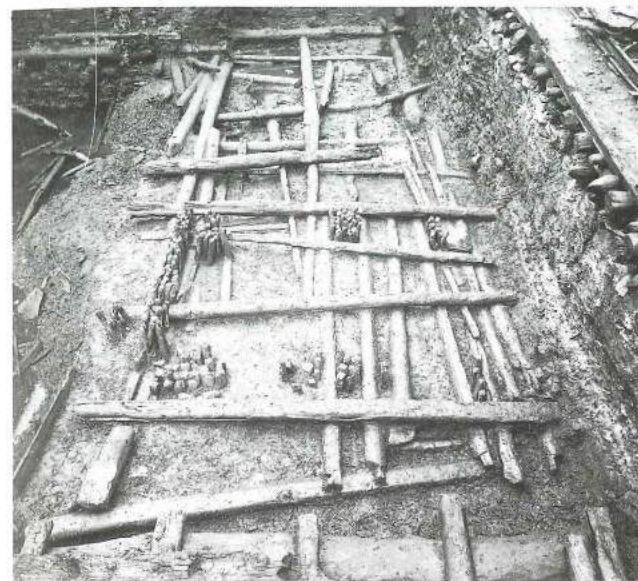
Fig. 13. Pile foundations from Phase 6.3 in Bugården North, looking west. The stakes have been driven down through the underlying Phase 6.2 foundations.

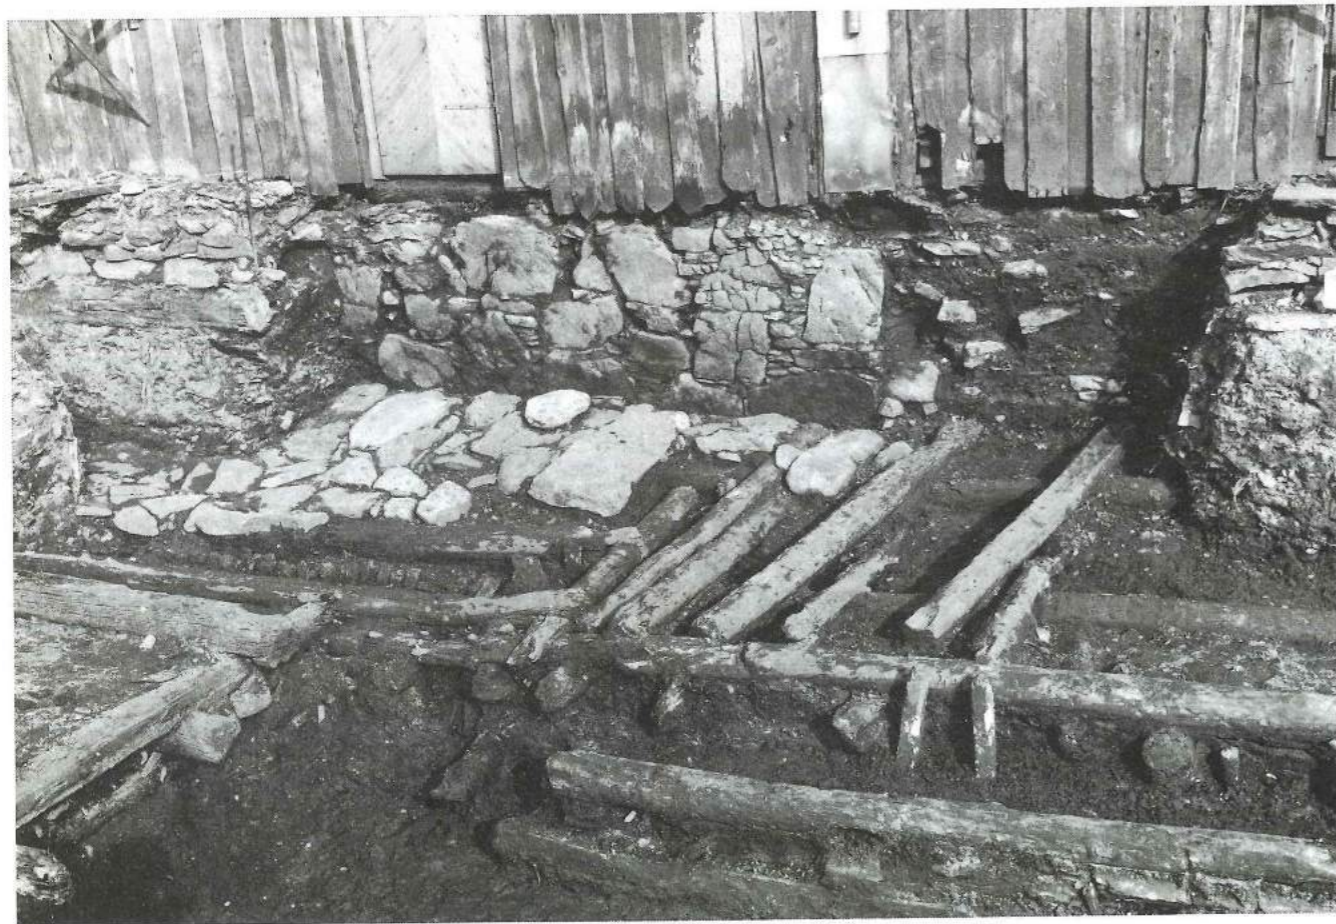
Fig. 15. Stone paving from Phase 6.2 in the public thoroughfare of Bua-almenning, looking south towards Bredsgården.

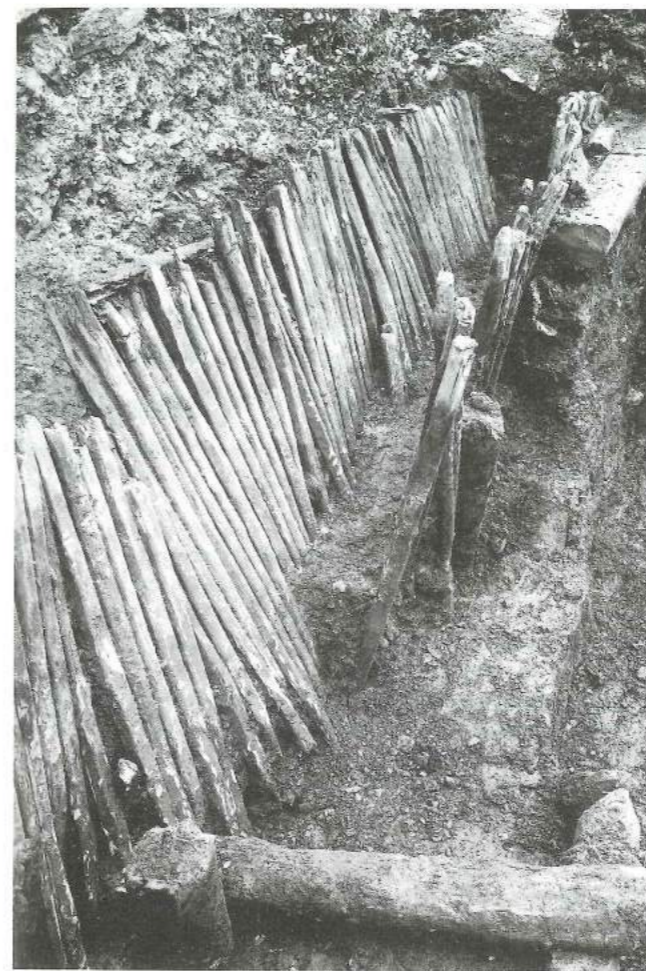
Fig. 16. Stake-lined drain from Phase 6.2 beneath the stone paving in the Bua-almenning thoroughfare.

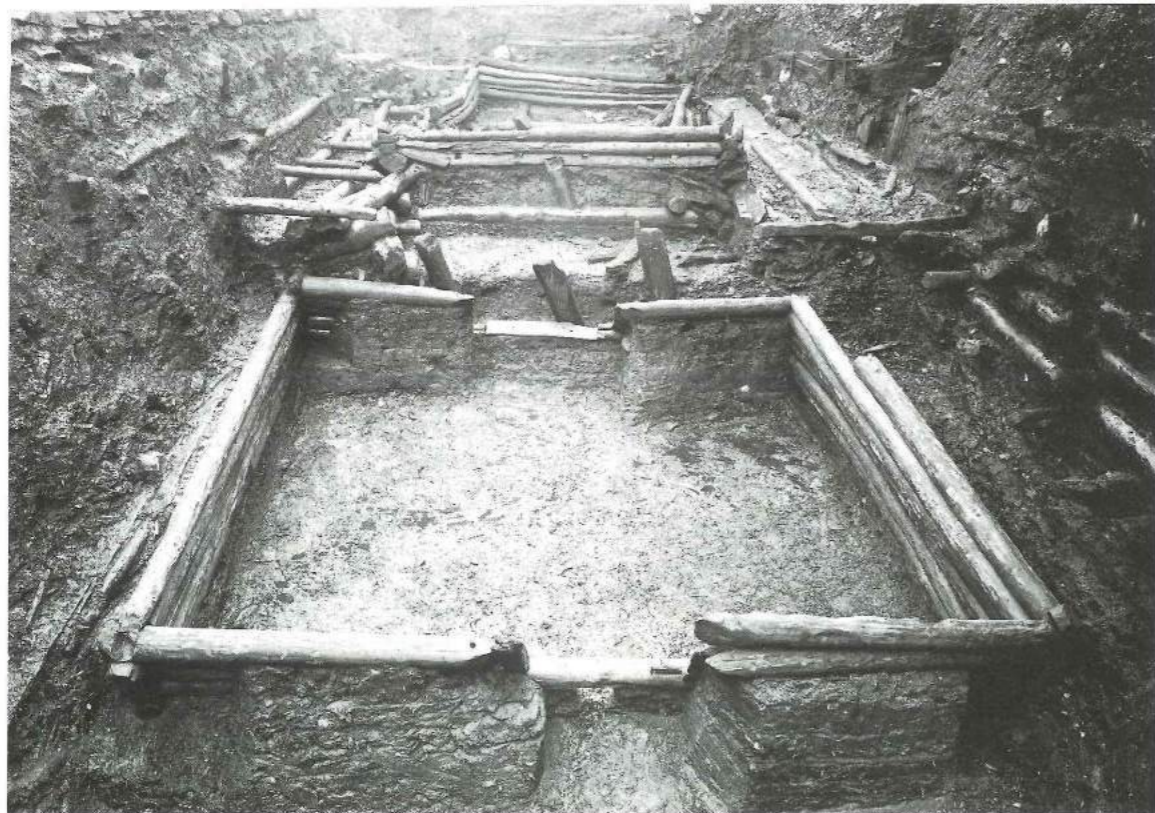
Fig. 22. Kar 92, the «Submarine House 1», in Bugården South, looking east.

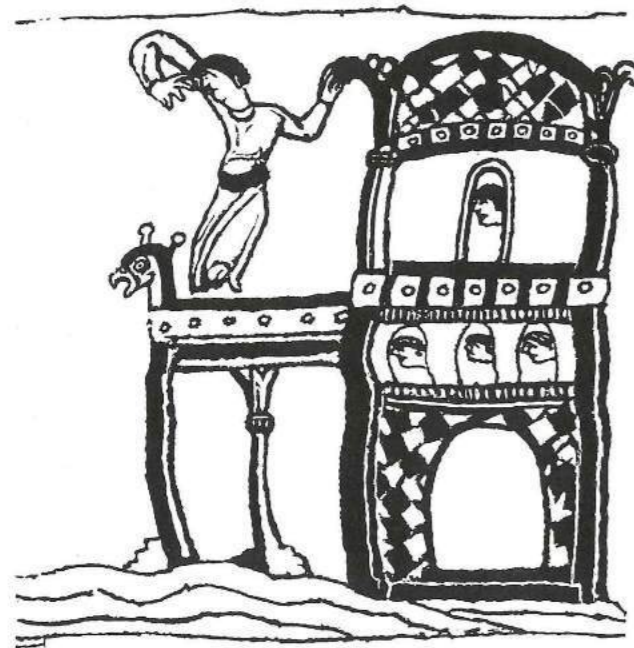
Fig. 30. An eleventh-century wharf in southern England as depicted on the Bayeux Tapestry.

The excavation of the Bugården tenement has provided for the first time a detailed insight into the way the wharfs were constructed in the Middle Ages. Apart from the wharf along 79y in Phase 3.2, which was log-built, the front part of the wharfs always consisted of some light structure, made up of a single layer of beams to which the planked surface was plugged. At the front, the beams were attached to a row of posts, which were either anchored individually at their base or else arranged on a common sill-beam. This is the same kind of construction as can be seen on the Bayeux Tapestry (see fig 30). Thanks to the

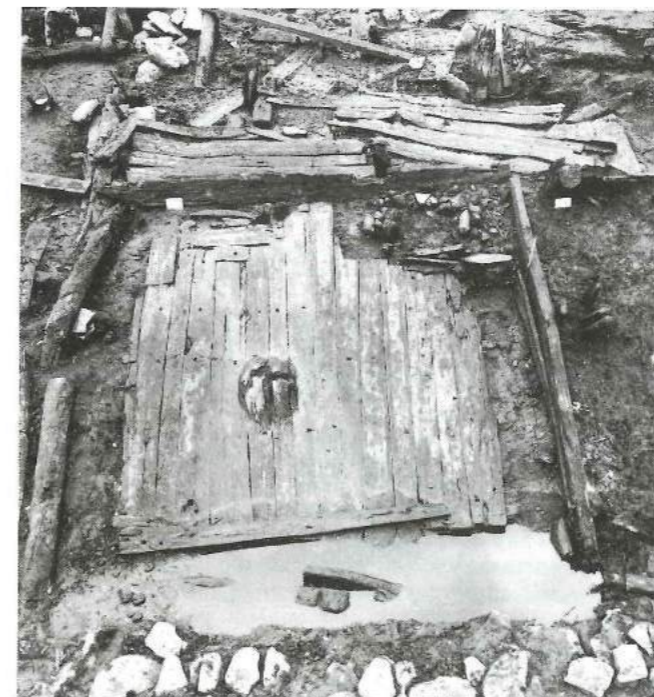
Fig. 49. Building 232 from Period 4 in Engelgården South seen from the west, with a relatively intact plank floor and sill-beams for the north, east and south walls. A fireplace (Hearth No. 14) lies in the south-east corner. The gap between the floorboards and the wall on the north, west and south sides indicates the existence of earth-filled wall-benches. The doorway was in the east wall.

Building 232 (M10,VI; N10,V) was probably a log-built construction with one room. Its remains consisted of the entire ground-frame and a well-preserved detached floor with longitudinal boards. It probably also had fixed wall-benches, since there was a gap of between c 50cm and c 75cm between the floor and the wall on the south, west and east sides (fig 49). In the south-east corner were the remains of a stone-built fireplace, Hearth 14 (fig 50). The door, which was in the east wall, had opened outwards. Eastern wall at 79.96y; western wall at c 92.4y. Length c 5.5m; width 4.50m.

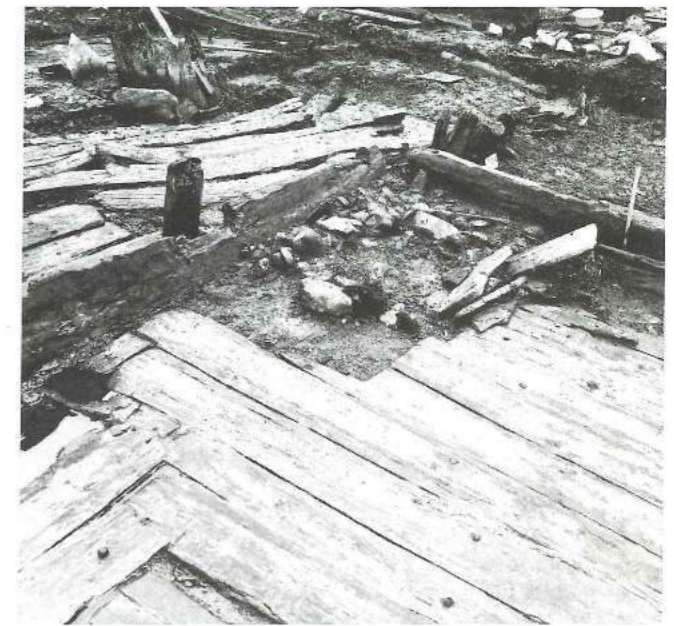
Fig. 50. South-eastern corner of Building 232, showing the remains of the fireplace (cf fig 49).

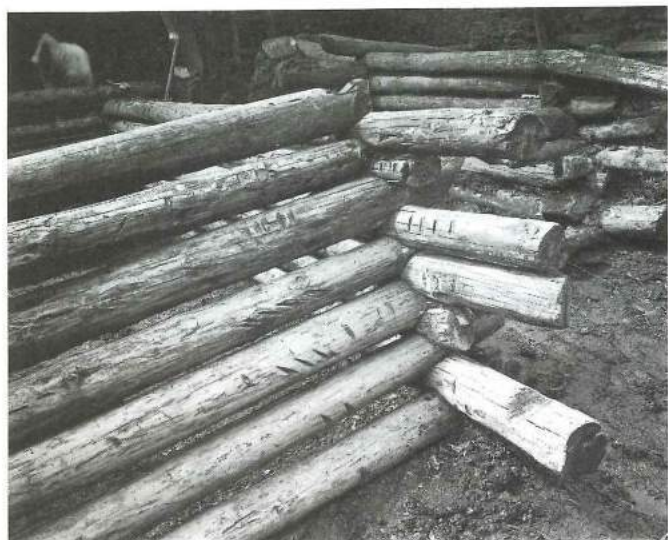
Fig. 51. Part of the Period 4 foundation substructure Kar 61 in Engelgården, seen from the south-east. The structure was prefabricated: the marks on the logs were for guidance when re-assembling it.

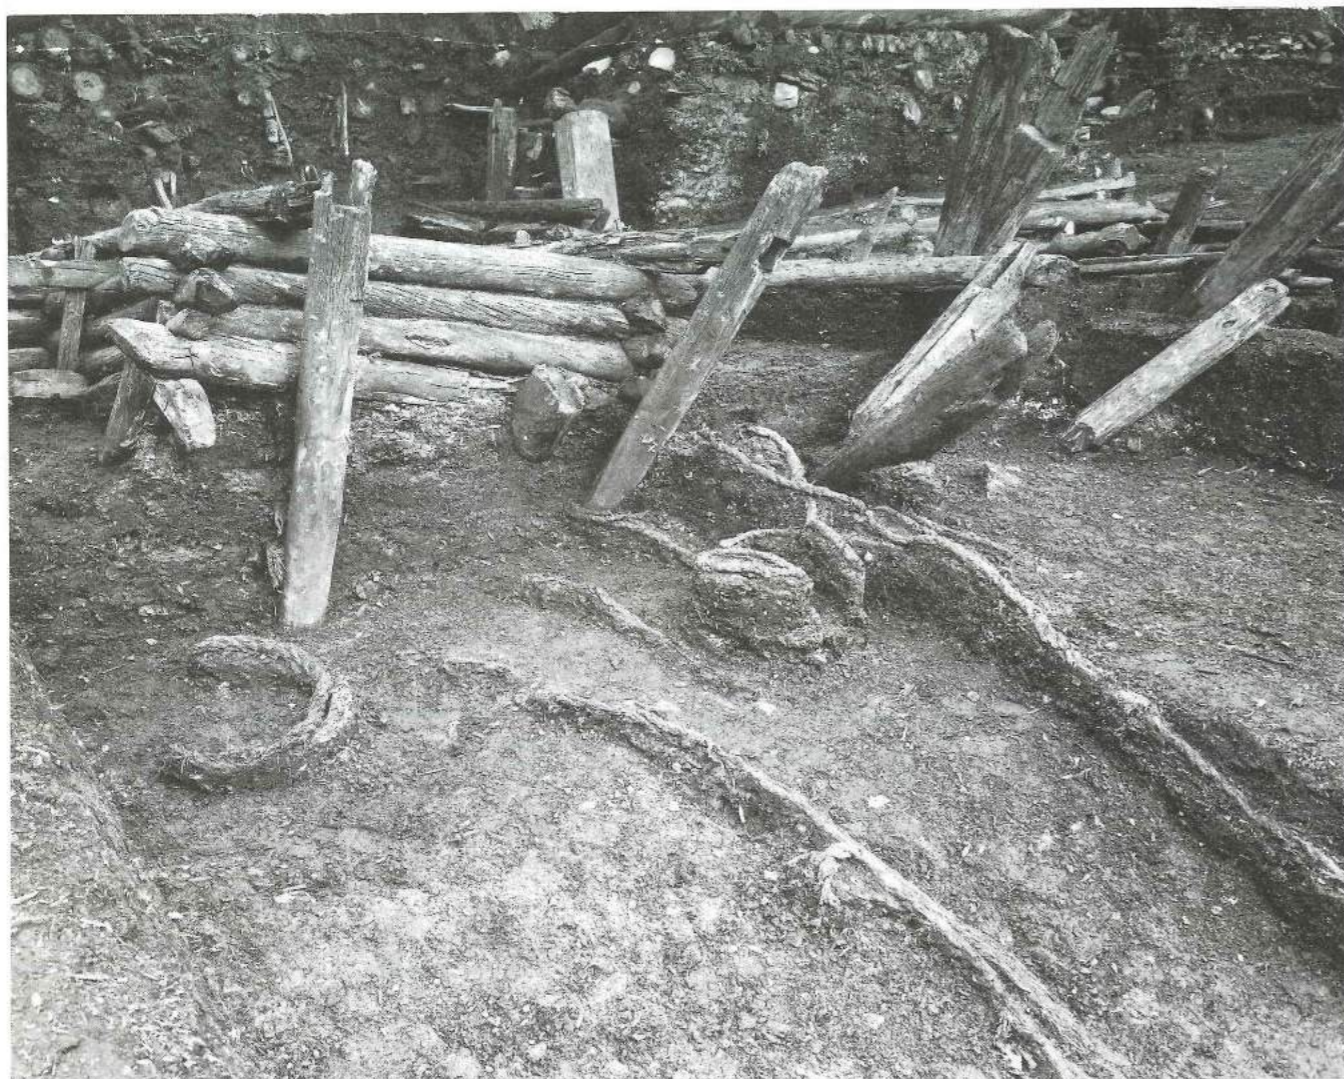
Fig. 54. The front substructures, Kar 55 and Kar 56, in Engelgården North, burnt in Fire VI (1198). The pieces of rope lie on the contemporary sea-bed. Looking towards the south-east.

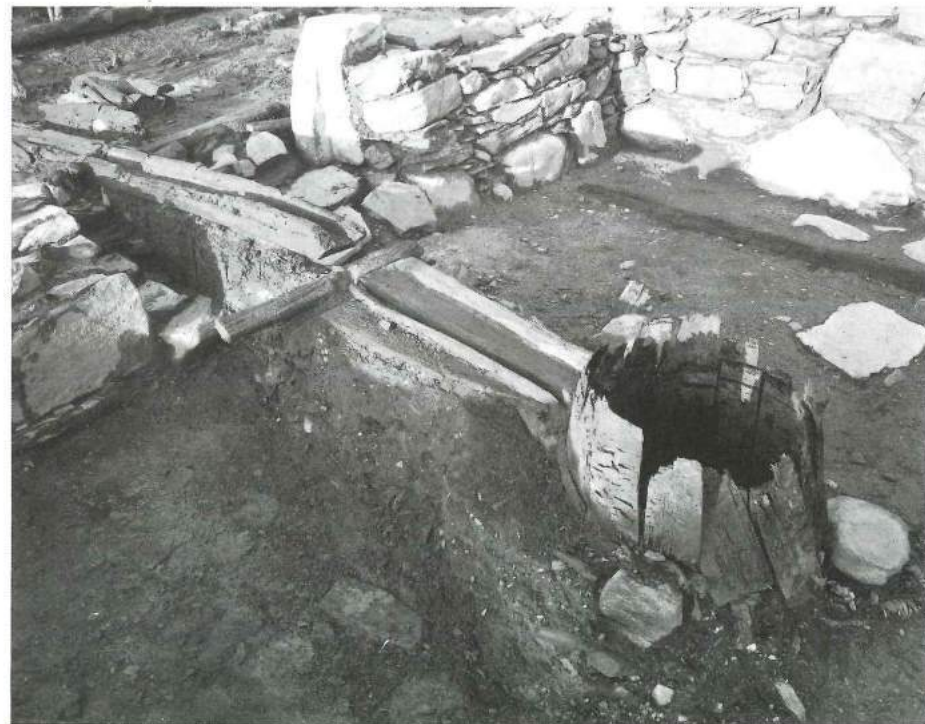
Fig. 66. The final stage of the overflow drain leading from a sunken barrel in the middle of Building 386 in Søstergården North (cf fig 62).

Building 386 (Phase 3) (fig 66) (K7,VI,VII). Some time after Fire III, a new road surface was laid outside the building. The underlying surface appears to have sloped steeply down to the west at an early stage, and outside the entrance to Building 386 the surface was raised c 35cm from 1.45m to c 1.8m above site datum. In the new log pavement a wooden-lined drain was laid, constructed like the first drain following Fire III. This drain, however, was practically intact throughout its entire length. It conducted the overflow from a barrel sunk in the floor in the middle of the room out under the flagstones in the doorway to the drain in the road. The cover of the drain lay at the same height as the log surface of the road, and the barrel, which had survived for its full height, must have been buried with its top just below the level of the floor.

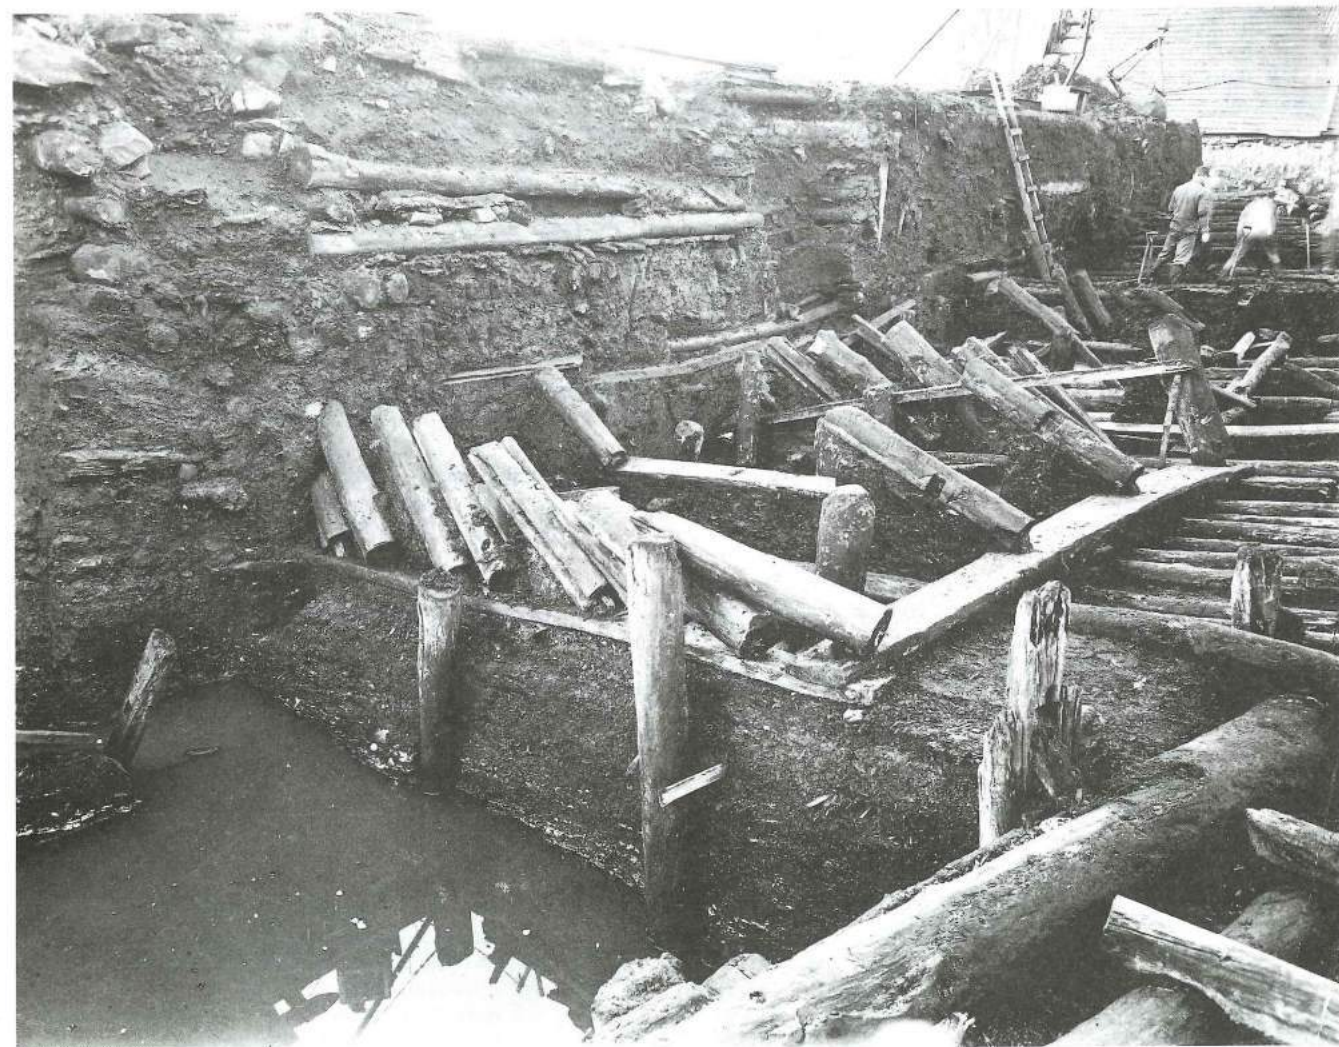
Fig. 72. Massive, well-preserved foundation posts, standing on sole-plates under Building 397 in Søstergården North, erected after 1332. Seen from the south-east.

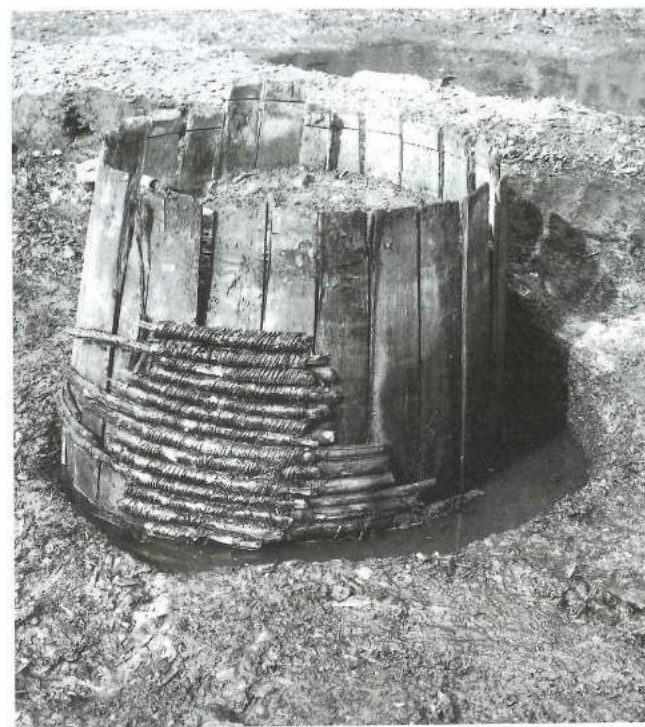
Fig. 74. Well 21 in Søstergården South consisted of a barrel which had been sunk through the remains of Building 123, burnt in Fire V (1248).

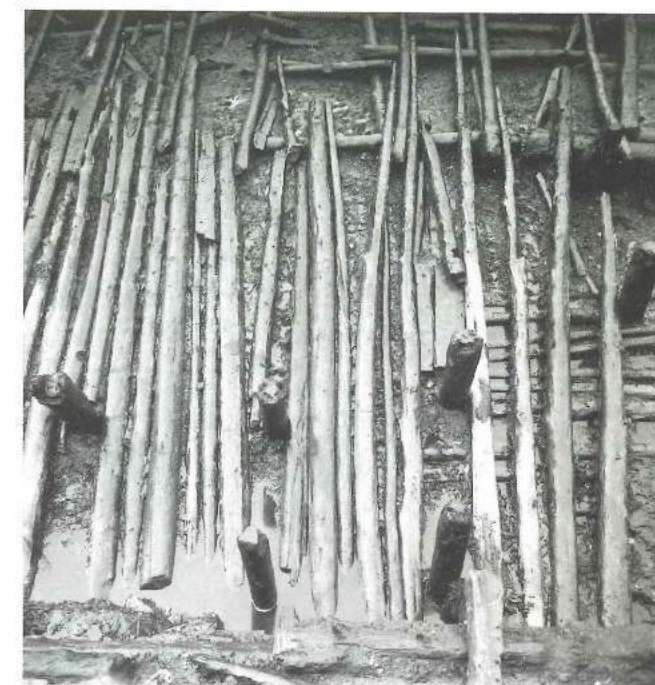
Fig. 75. Layer of logs laid close together to level up the ground in Søstergården North and the adjacent area of Gullskoen after Fire VI (1198). The cross logs in the background belong to the wharf of the preceding phase, burnt in Fire VI.

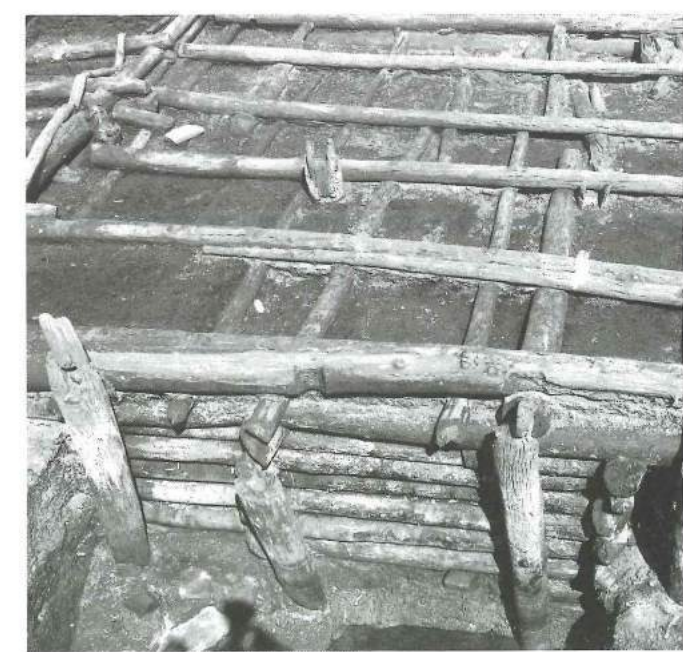
Fig. 77. Part of the waterfront in Søstergården burnt in Fire VI (1198), seen from the west.

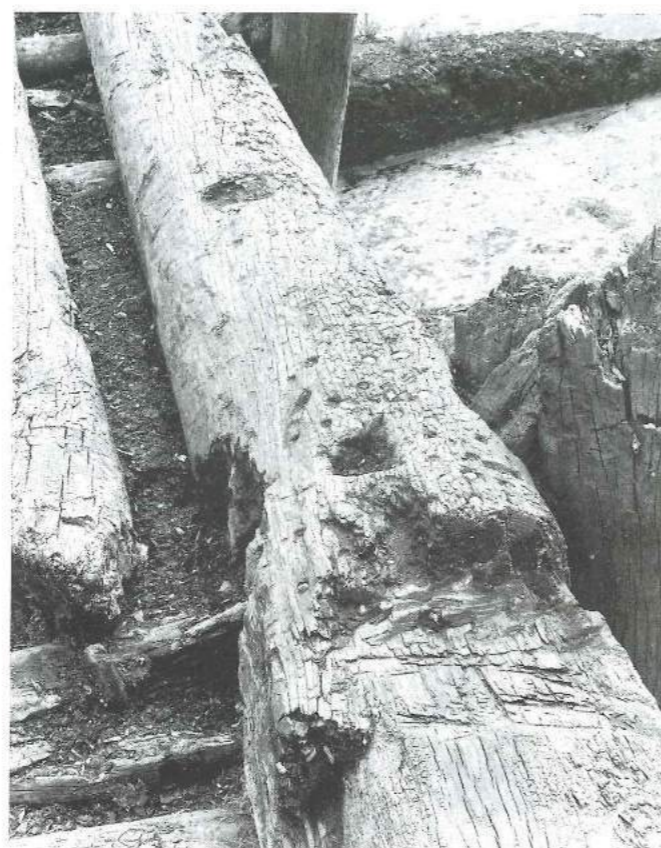
Fig. 79. Close-up of the horizontal beam at the front of the Søstergården South wharf at the beginning of Phase 3.2. It was embedded with stones to provide a better grip for the feet when embarking or disembarking.

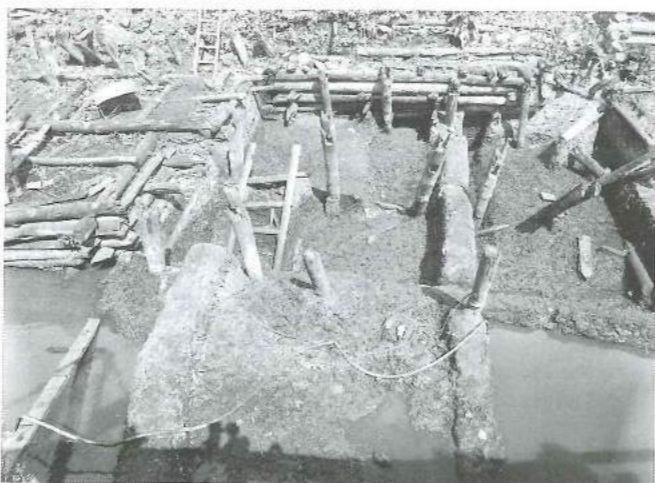
Fig. 83. Søstergården South looking east, with the front of the foundation substructure Kar 113 from Sub-phase 3.1.1 in the background and the posts of the associated quay in front of it, together with the remains of a ladder, which had originally leaned against the front of the quay in this phase. The three posts in the foreground belong to a later phase.

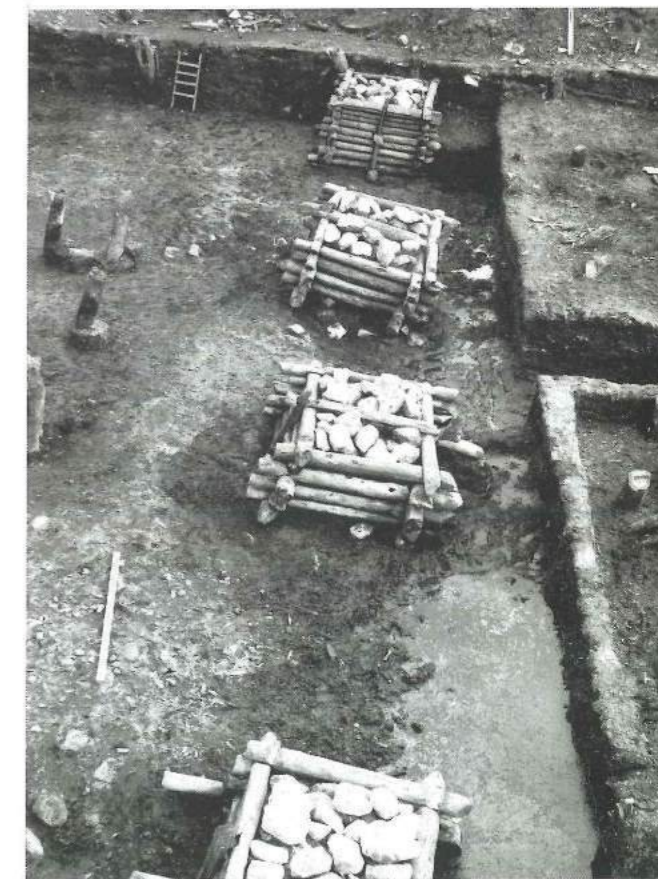
Fig. 86. Caissons 40, 43, 41 and 42 in the long row of foundation substructures belonging to Period 2 (up to 1170/71) located at the front of the beach on the edge of the underwater shelf. Seen from the north.

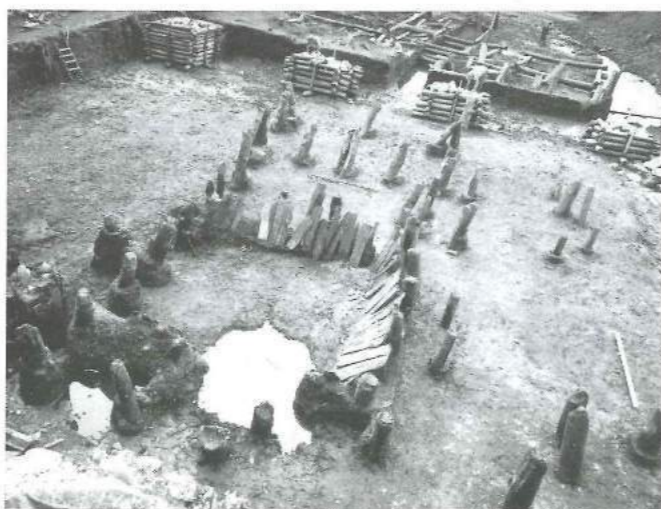
Fig. 87. In the foreground: Building 130 in Søstergården North, supported on posts, seen from the east. The gap under the floor was enclosed with upright planks placed edge to edge. Posts belonging to Building 402 can be seen to the west of this building. In the background, the contemporary waterfront is marked by the row of caissons along the bottom of the beach (from right to left: 40, 43, 41 and 42).

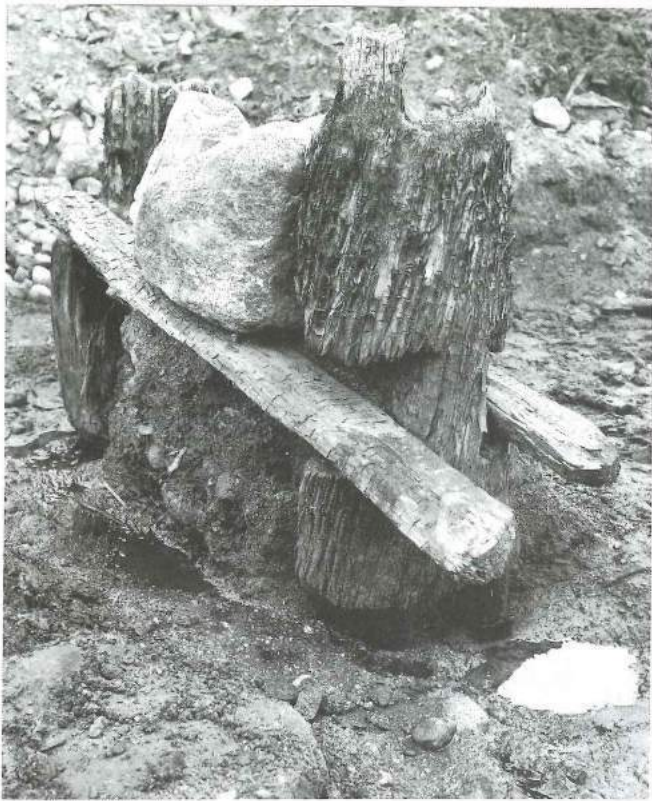
Fig. 89. Pair of foot-braced posts from a jetty at Borgund-kaupangen in the district of Sunnmøre.

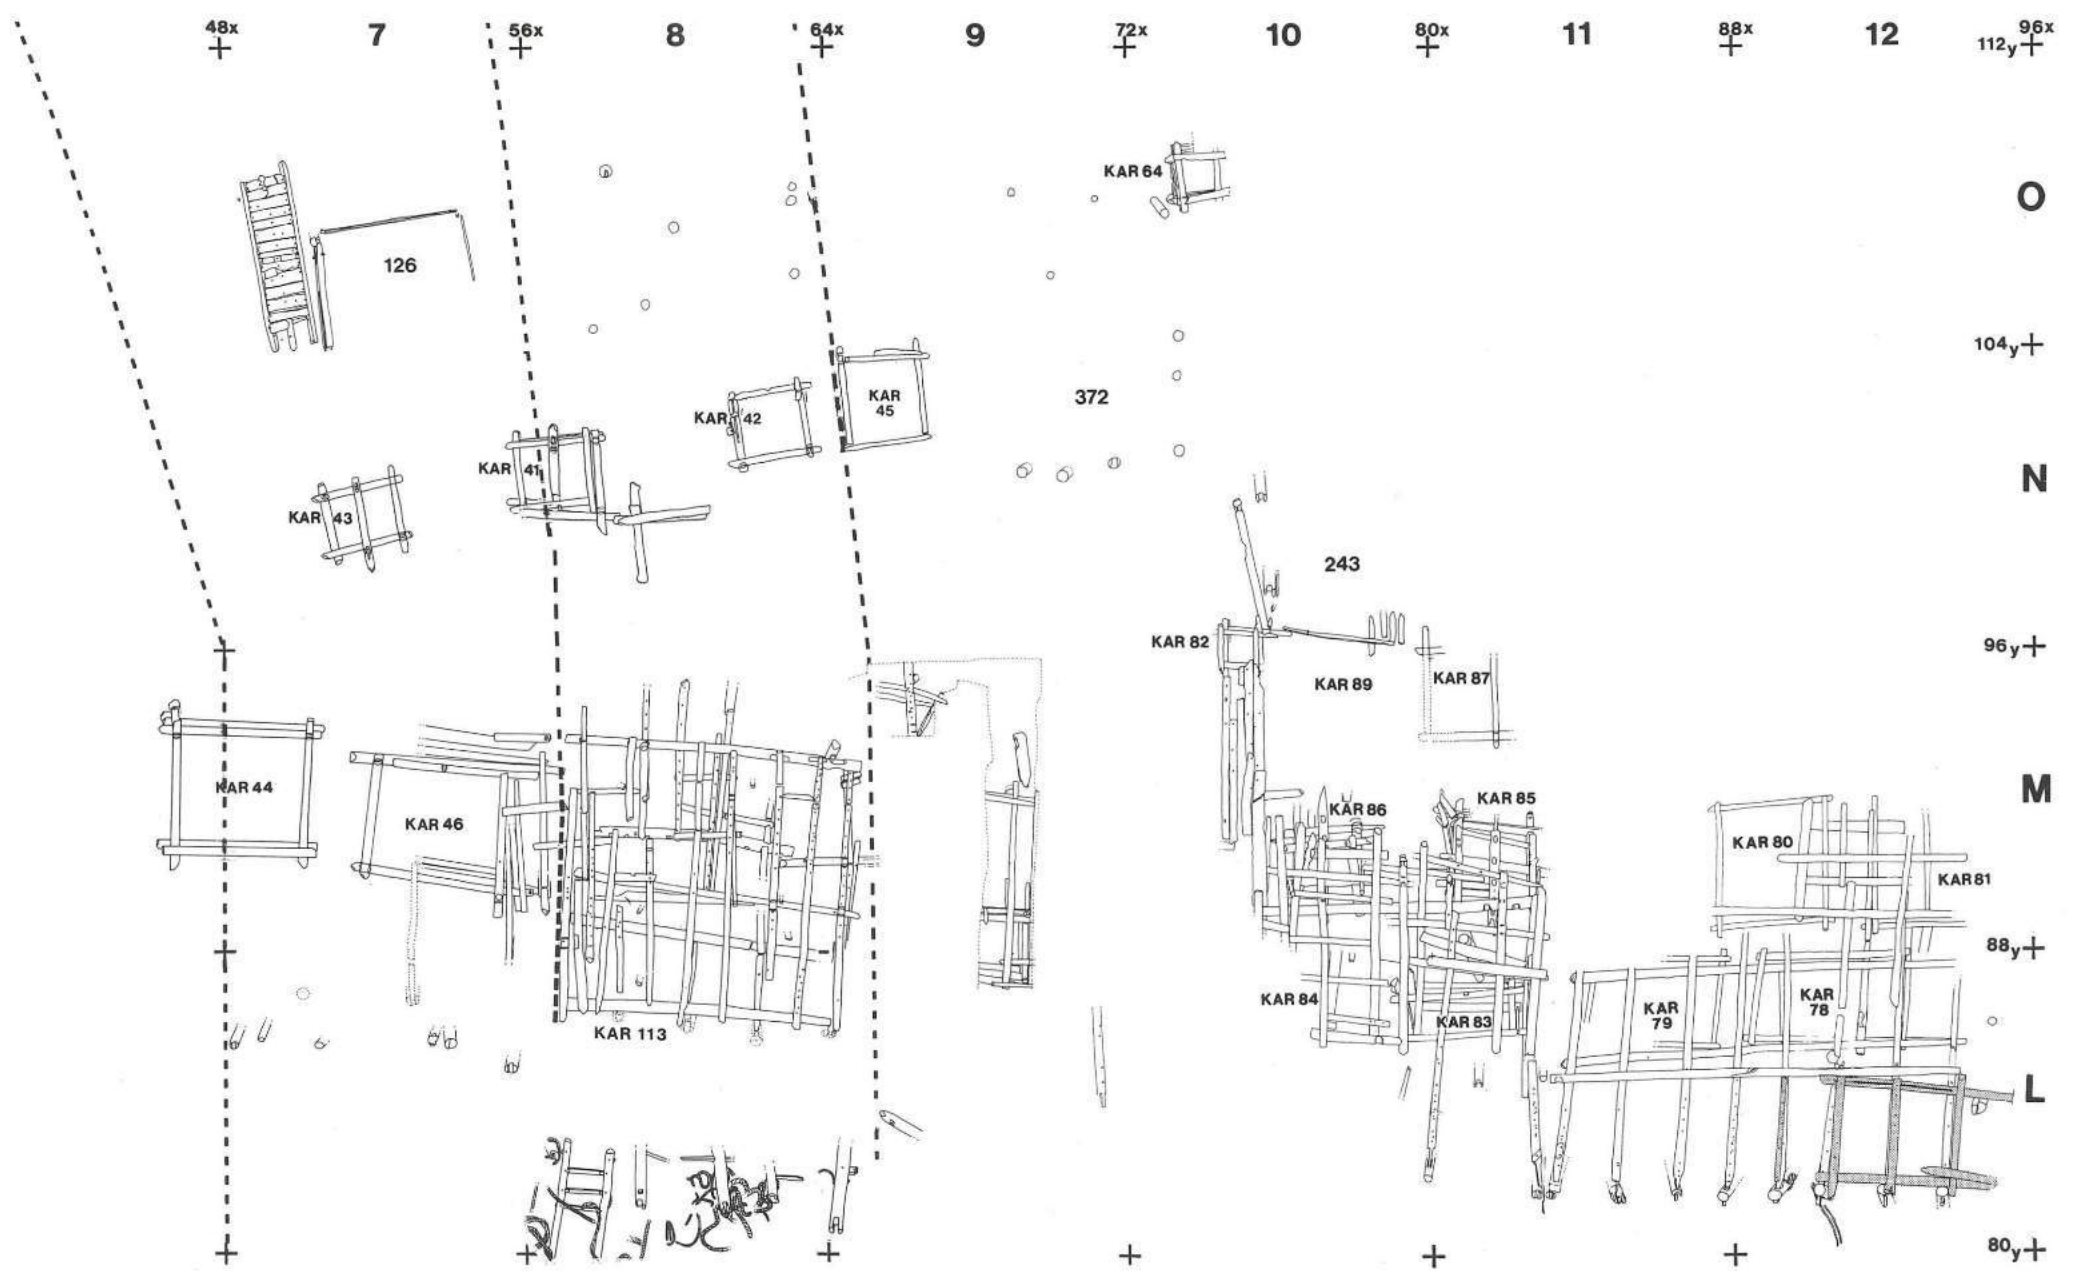
Fig. 91. General plan of Bugården, Engelgården and Søstergården, showing the waterfront in Phase 3.1.

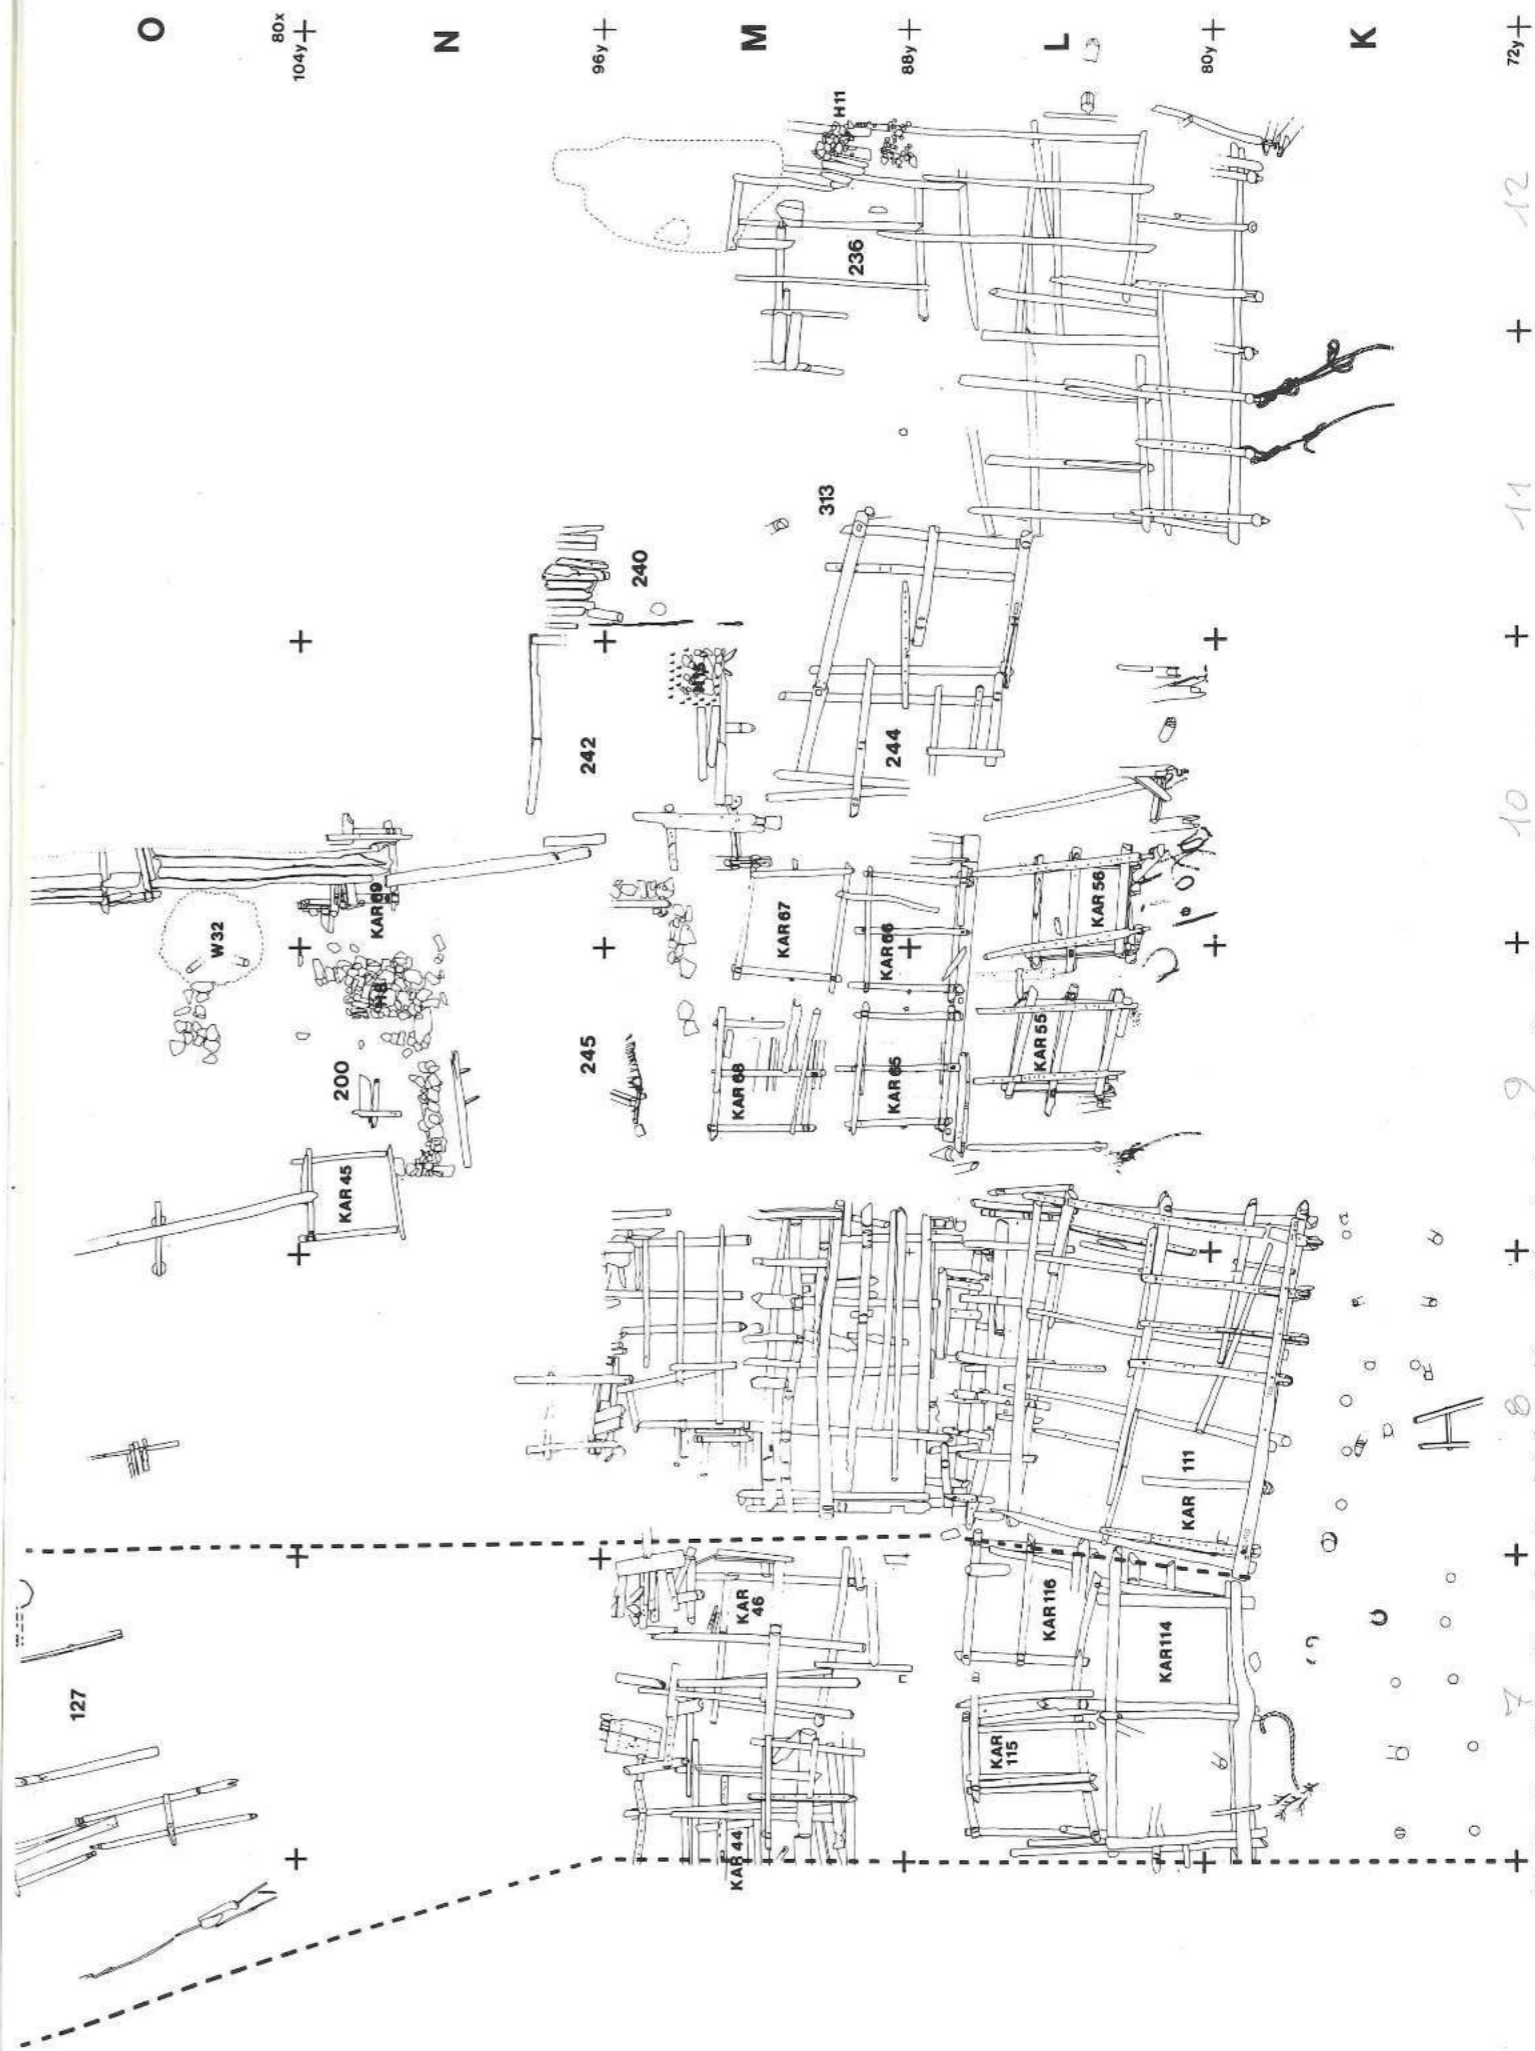
Fig. 92. General plan of Bugården, Engelgården and Søstergården, showing the waterfront in Phase 3.2, burnt in 1198.
