# THE BRYGGEN PAPERS

MAIN SERIES · VOL 3, PART 2

THE BUILDINGS AT BRYGGEN  
THEIR TOPOGRAPHICAL AND CHRONOLOGICAL DEVELOPMENT

*Asbjørn E. Herteig*

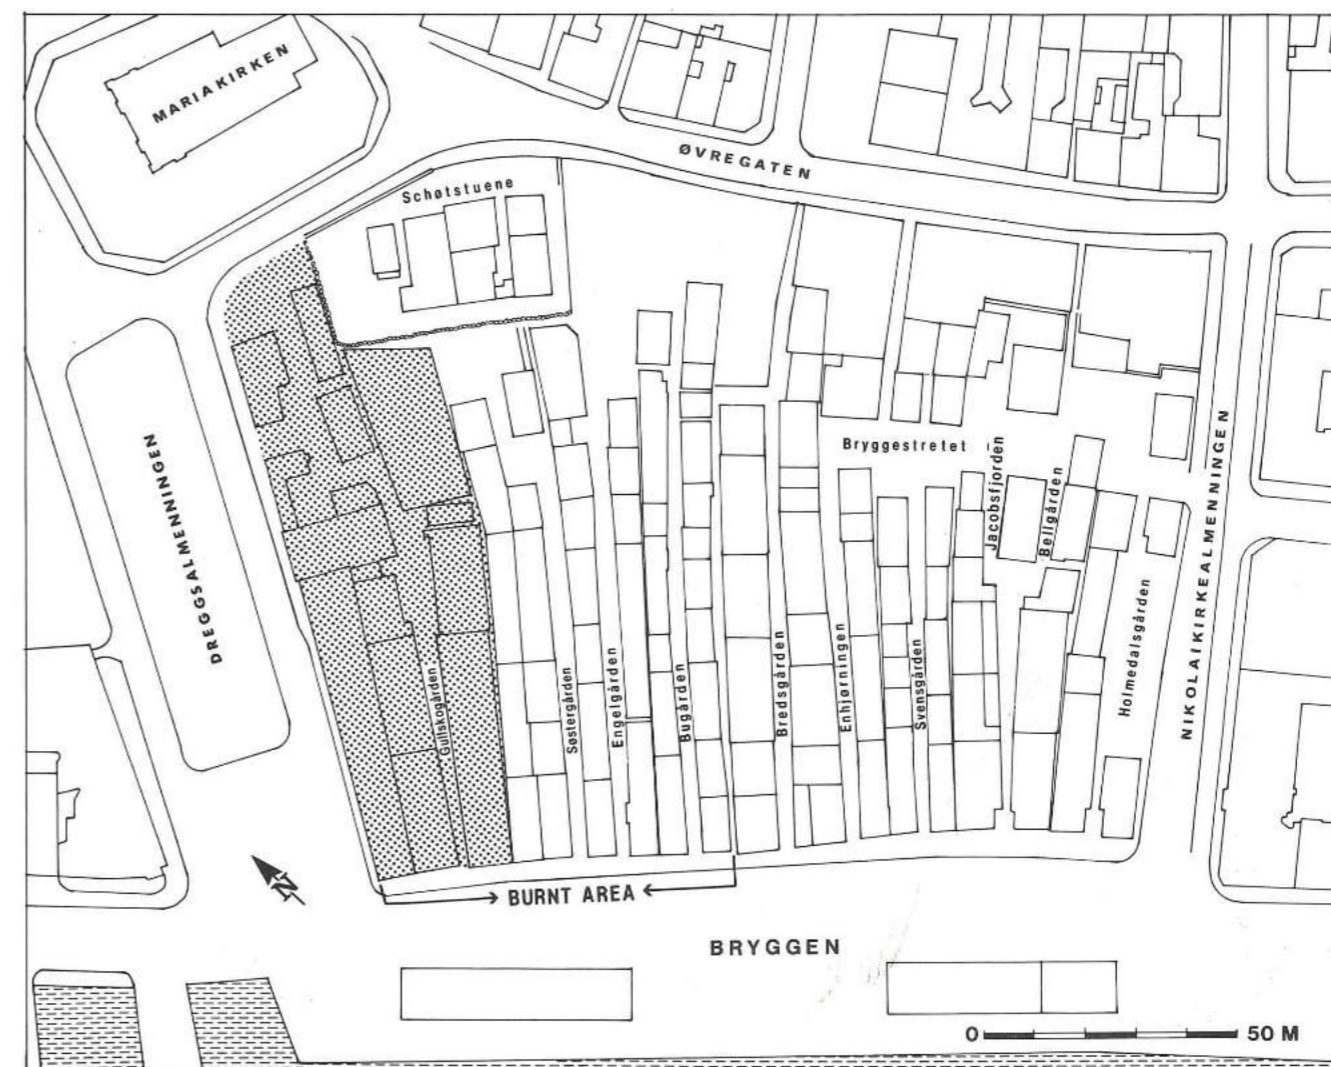
Fig 2 Plan of Bryggen before the 1955 fire. The Gullskoen area is shaded.

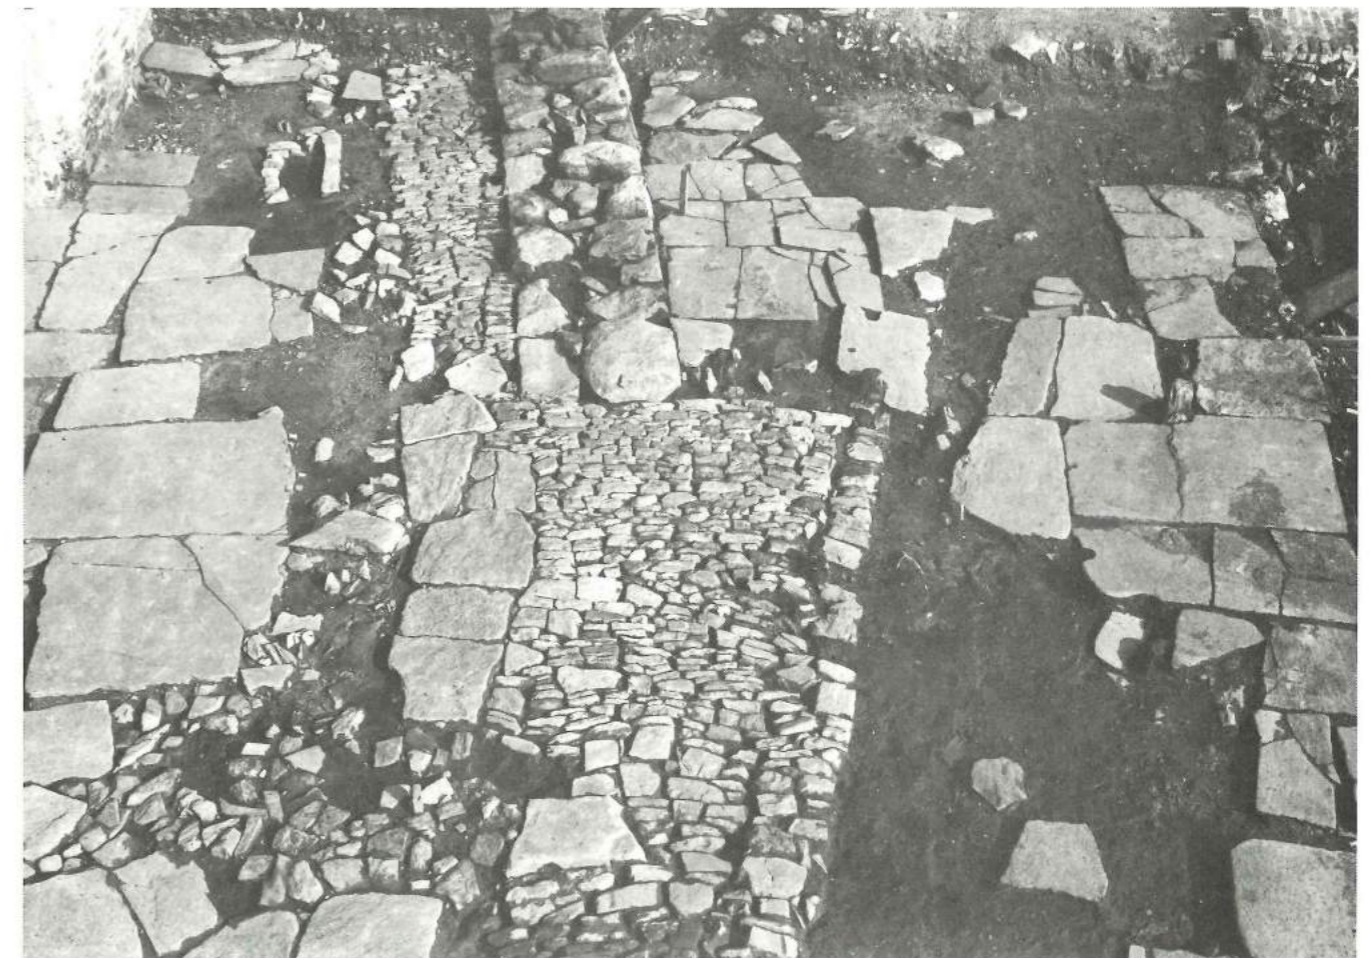
Fig 6 Stone paving in the open areas of Gullskoen, Phase 9.1.2.

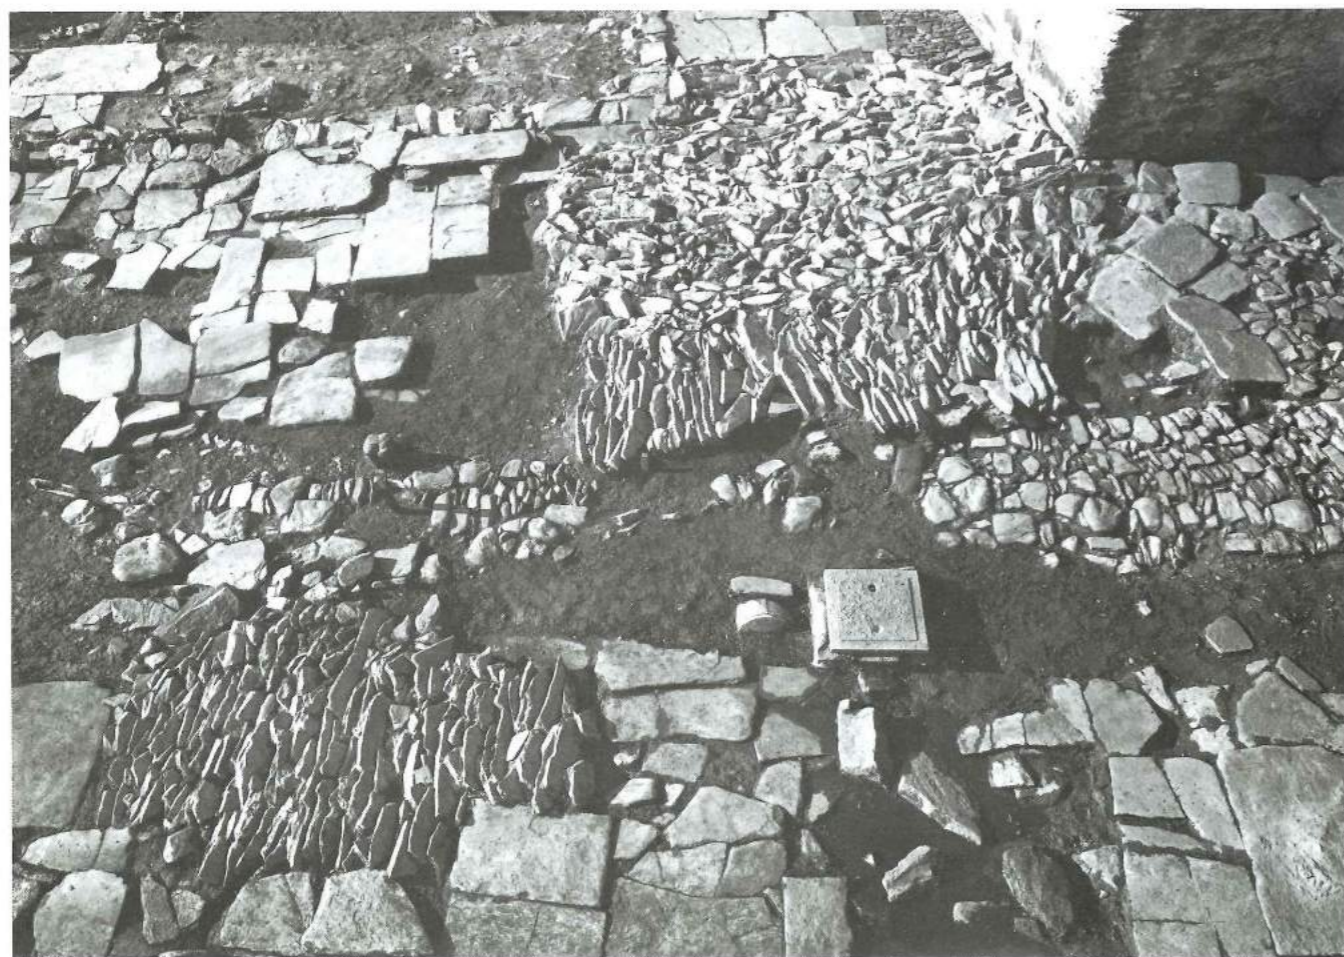
Fig 7 Different types of stone paving on the Gullskoen site, Phase 9.1.2.

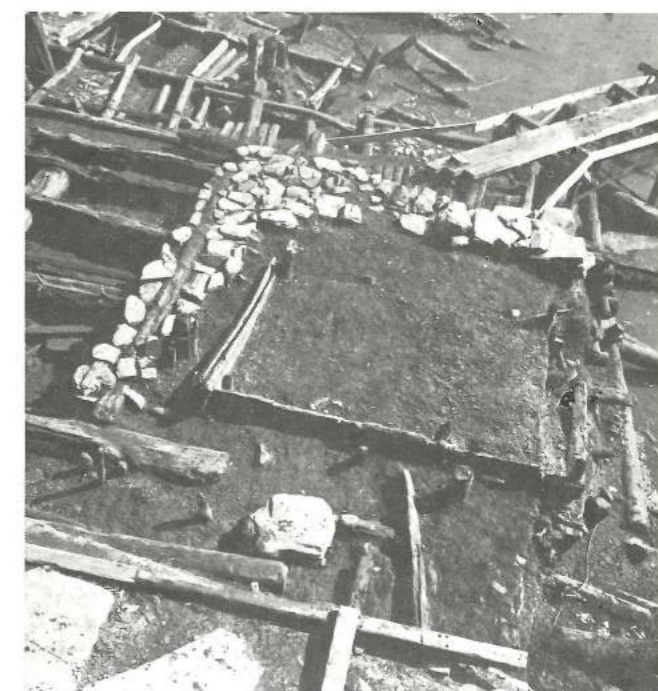
Fig 11 The remains of the structure labelled Building 180 lying inside the ground-walls of Building 181 which ran across the tenement. Looking south.

Building 180 (K4,IV; L4,III) was a simple rectangular construction lying within the eastern part of the foundations of Building 181, which must originally have gone down c 1m into the ground (cf fig 11 & pl 3). It had walls of horizontal planks held in place by upright corner posts. Its function is unknown. Its length averaged 3.75m; width 2.5m.

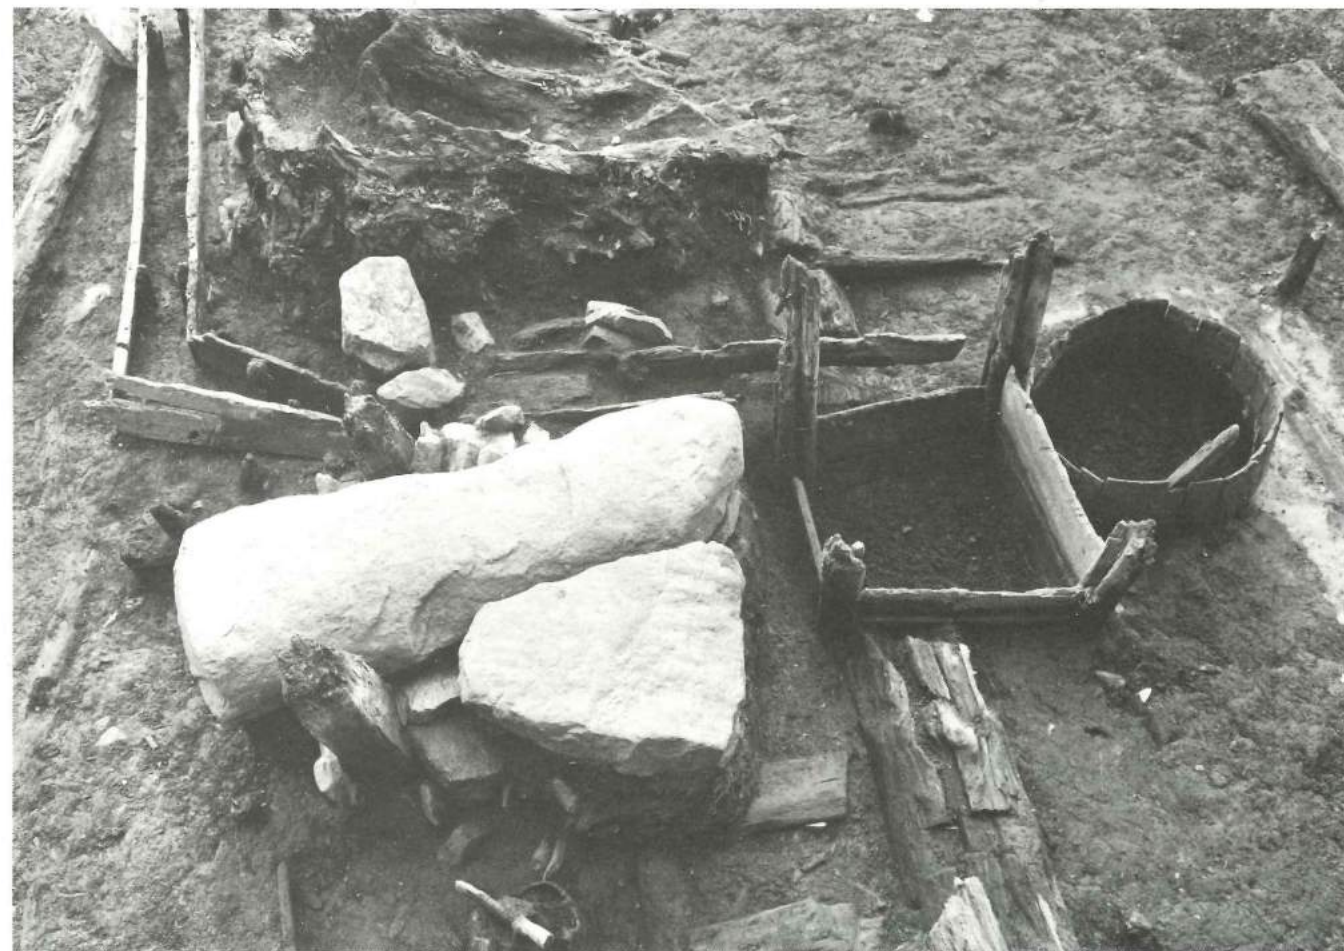
Fig 12 A laundering place beside The Old Church Road in Period 8 (1476–1702) marked by Well 41 (lined with boards slotted into corner uprights), Well 42, which is formed from a sunken barrel, and a stone washing-slab. The remains of a drainage channel run from the washing-slab towards a large tree whose roots can be seen in the background. Looking west.

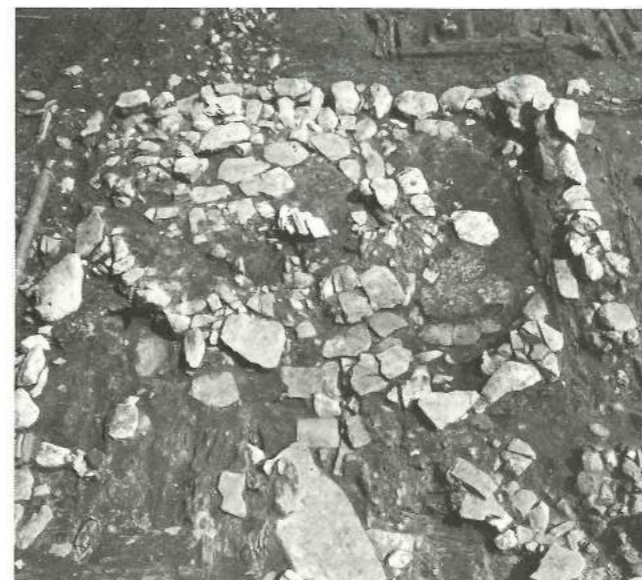
Fig 15 Base of Hearth 17, probably used mainly in the production of slaked lime. Looking south.

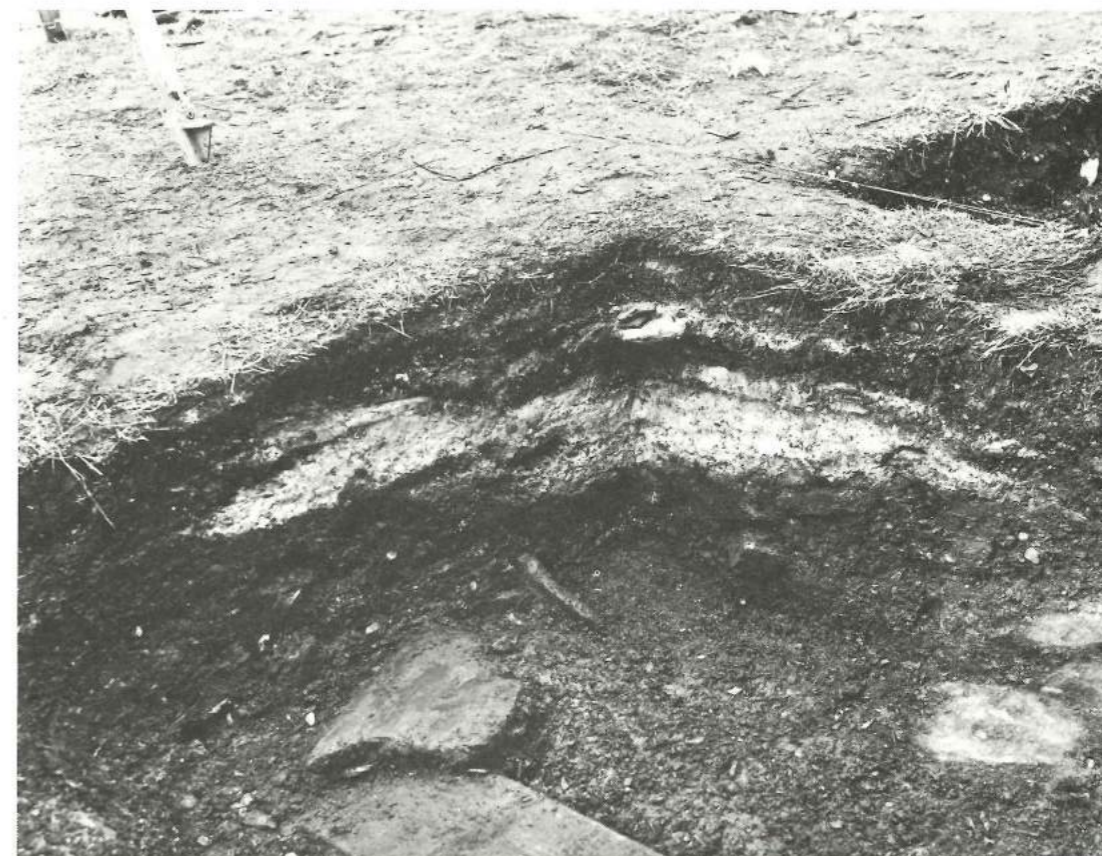
Fig 16 Cross-section showing the various strata in a pit in Building 227 used in connection with lime slaking.

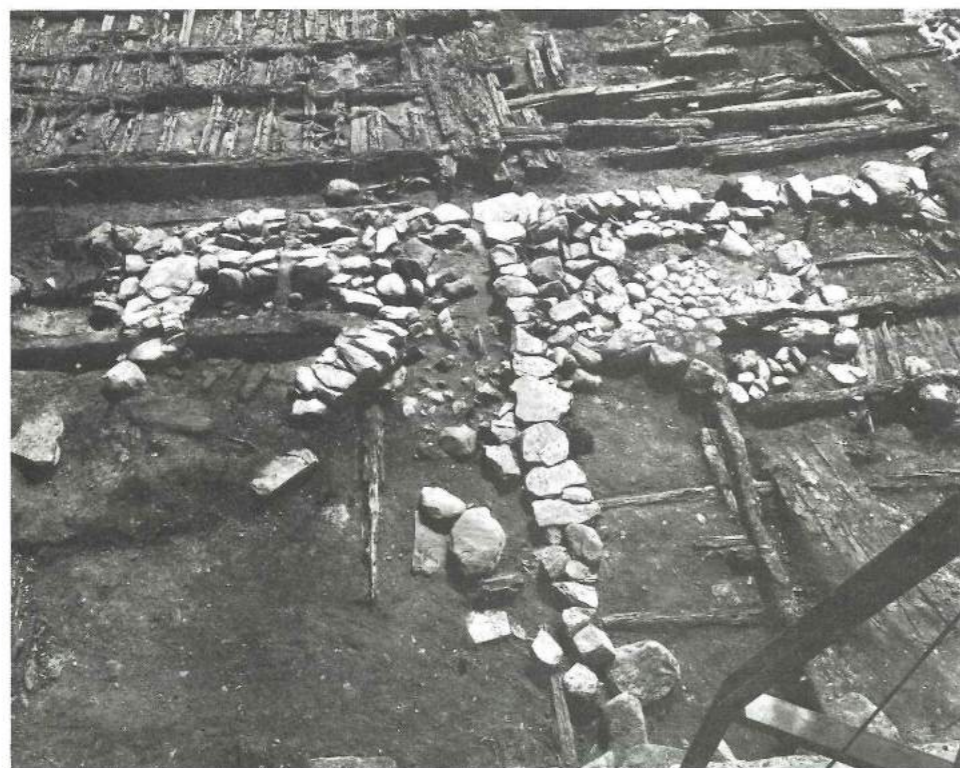
Fig 18 Hearths 1 and 2 in Buildings 441 and 6 respectively, burnt in Fire III (1413).

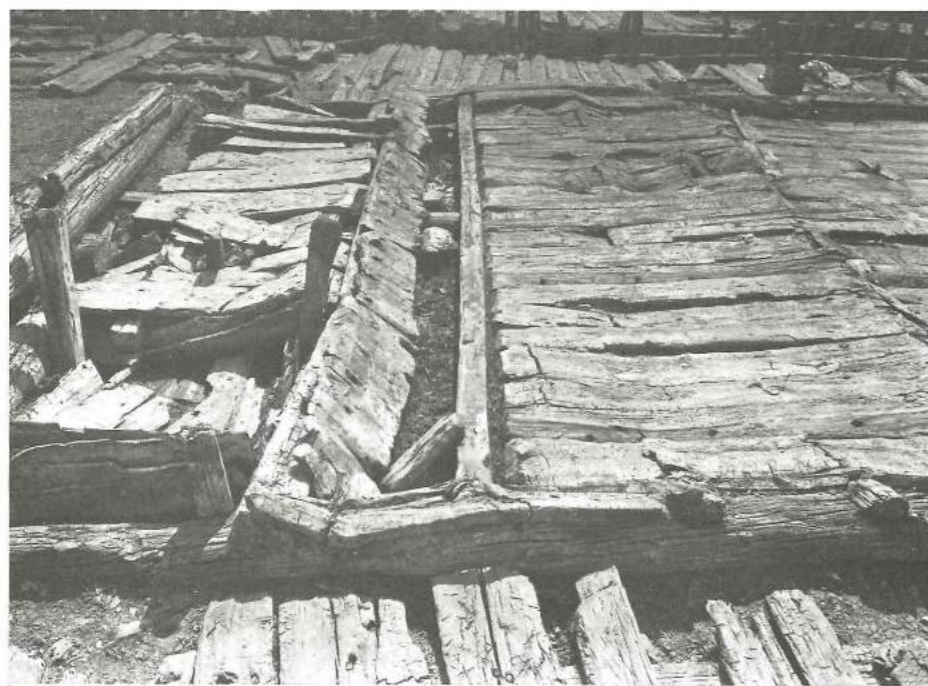
Fig 19 Eastern part of Building 430 with a floor laid lengthwise. The boards have later been cut through, leaving the short ends sticking up at an angle. A new sill-beam lies to the left of a later transverse floor. To the east, Privy 10 is situated at the end of the gap between the buildings. Seen from the north.

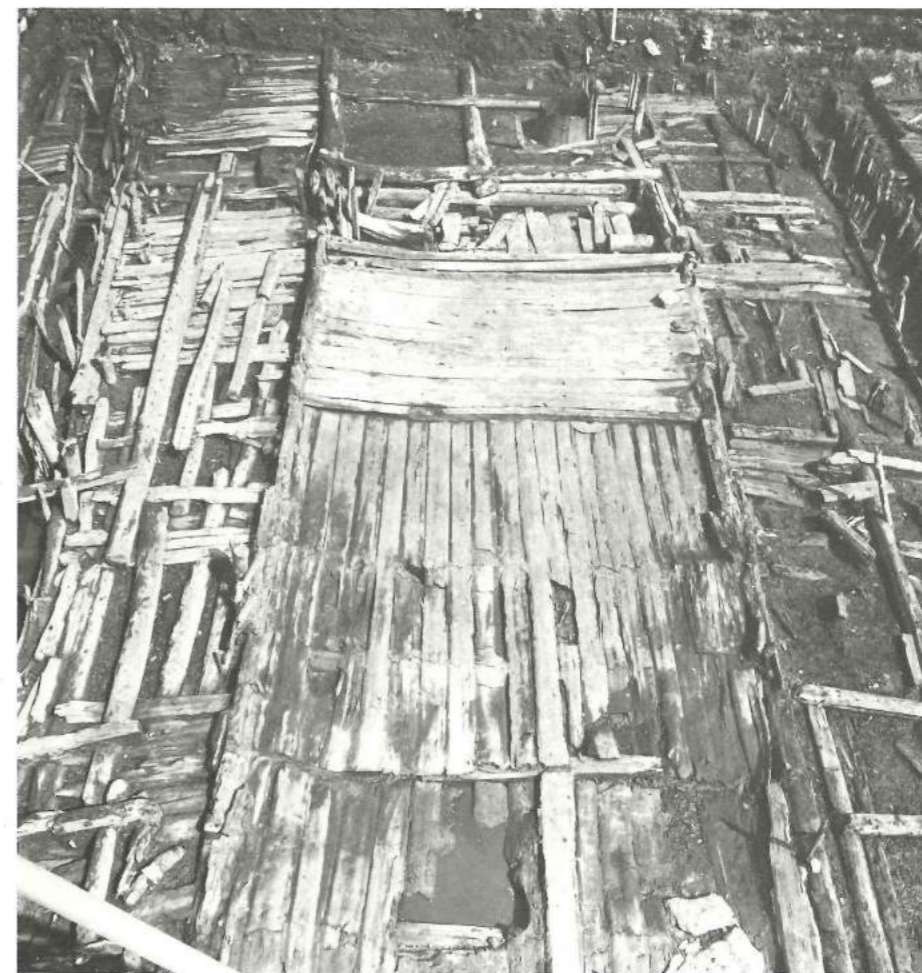
Fig 20 Building 430 with a secondary transverse floor laid over the original longitudinal floor and Privy 10 in the gap to the east of the building. Looking east.

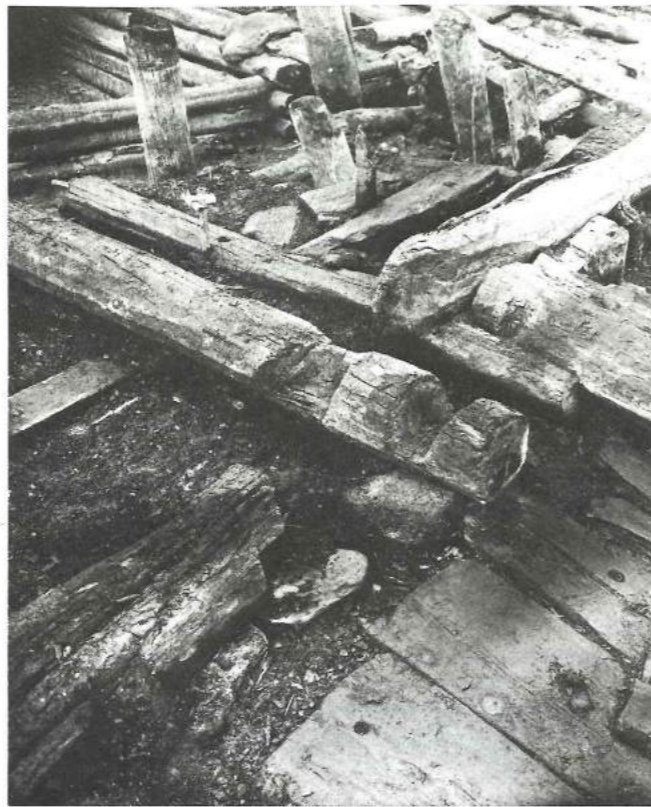
Fig 23 North-east corner of Building 221 with the original lapped corner beyond. A new north wall has been erected in timber-framing. Seen from the north-east.

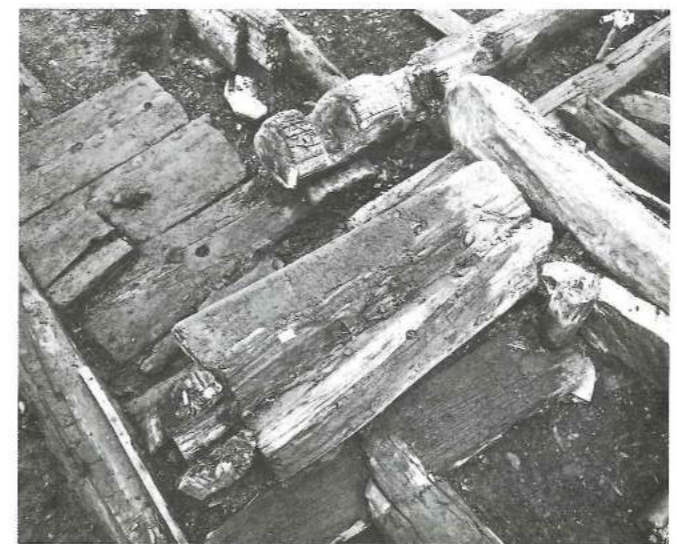
Fig 24 Detail of the north-east corner of Building 221 as shown in fig 23 with the remains of the base of a stair in the adjacent passage. Seen from the north-west.

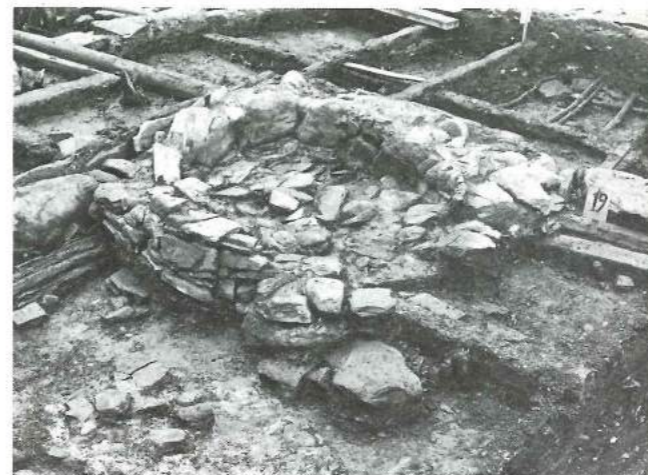
Fig 25 *Hearth 6, a large stone hearth in Building 19, burnt in Fire IV (1332). Seen from the north-west.*

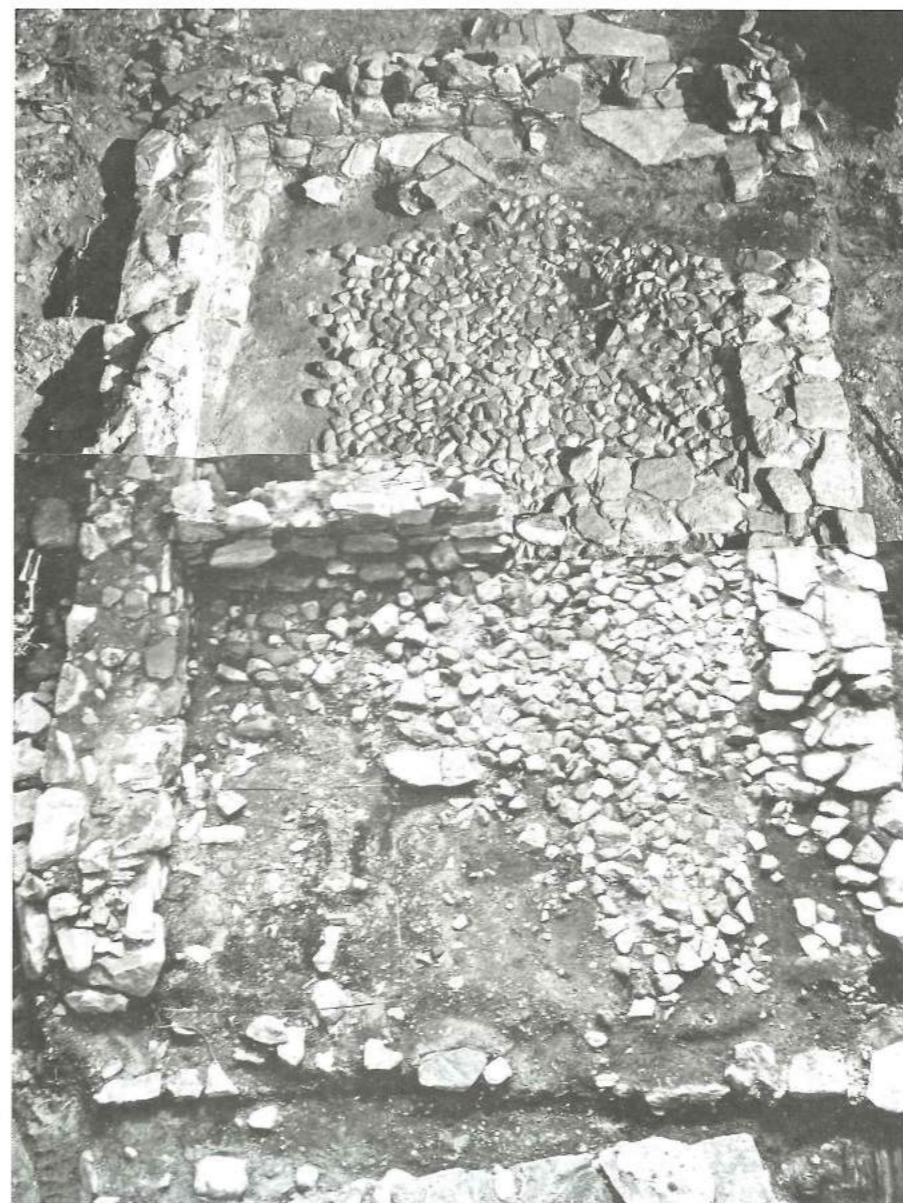
Fig 26 The two-room plan of the St Mary's Guildhall, with the entrance on the south side adjacent to The Old Church Road. The south wall of St Lawrence's Church lies in the foreground. Looking south.

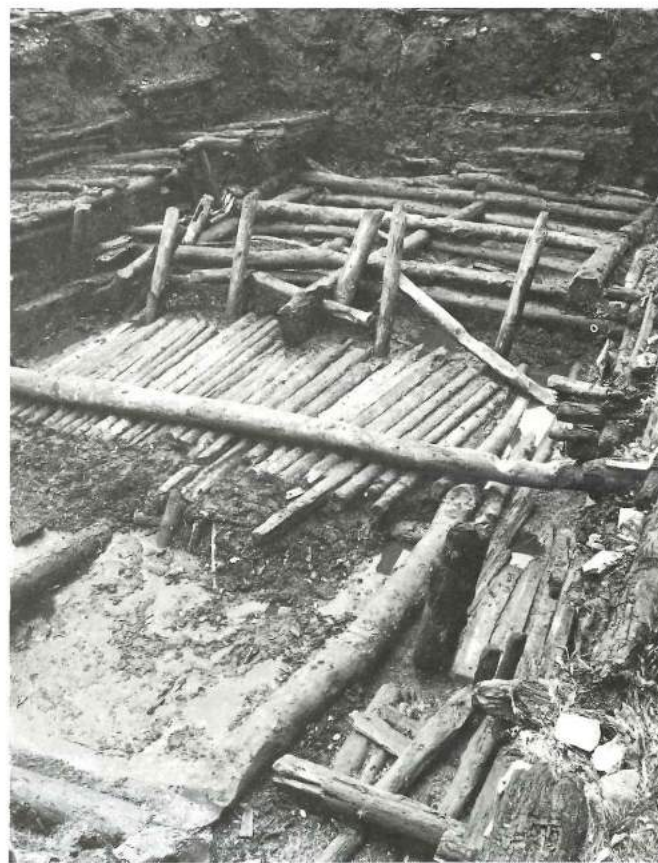
Fig 32 Logs placed close together over the foundation substructure Kar 117 in order to level up the surface. The posts of the contemporary quay can be seen in front. Period 4 (1198–1248). Seen from the north-east.

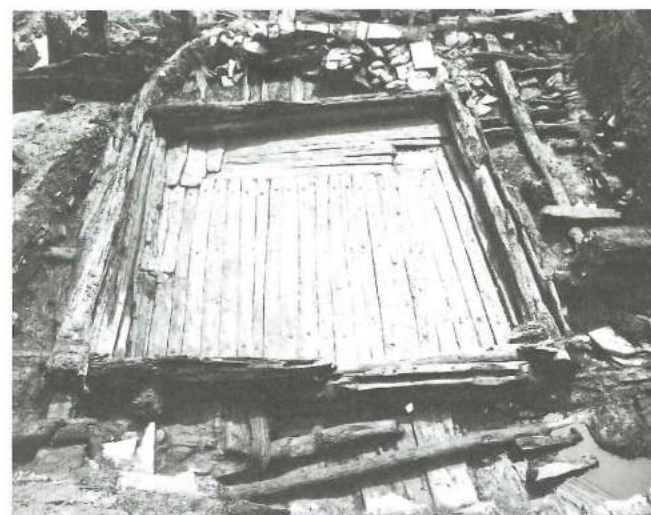
Fig 34 Ground-frame of Building 211 with intact floor, burnt in Fire V (1248). Looking south.

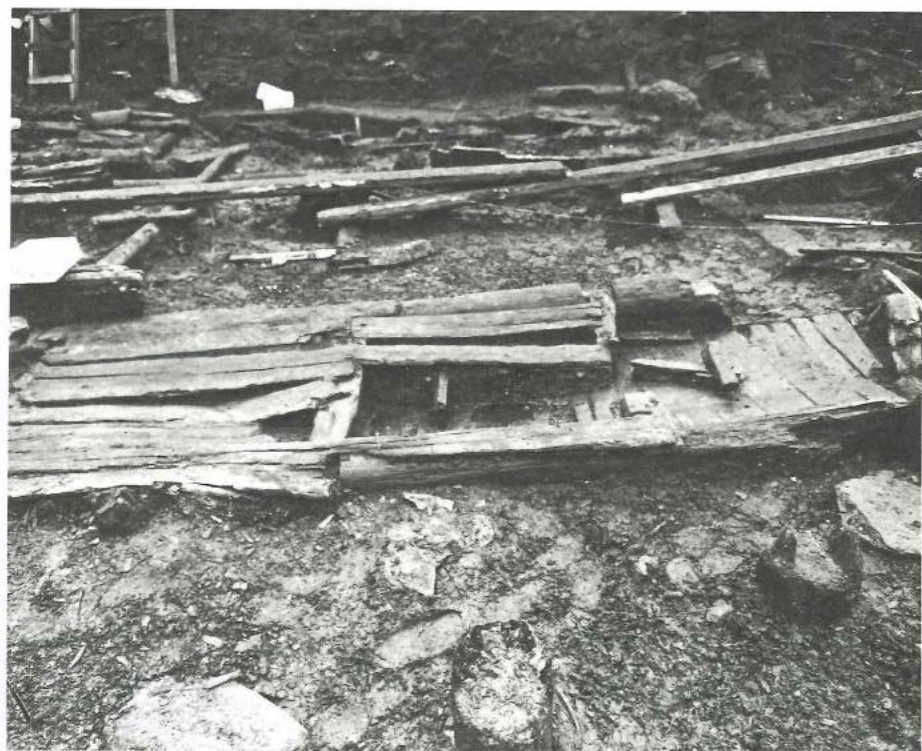
Fig 37 Part of the passage with longitudinal planking between Rows 1 and 2 in Phase 3.2, burnt in Fire VI (1198). The boards have been laid directly on top of the earlier transverse surface from Phase 3.1. Looking north.

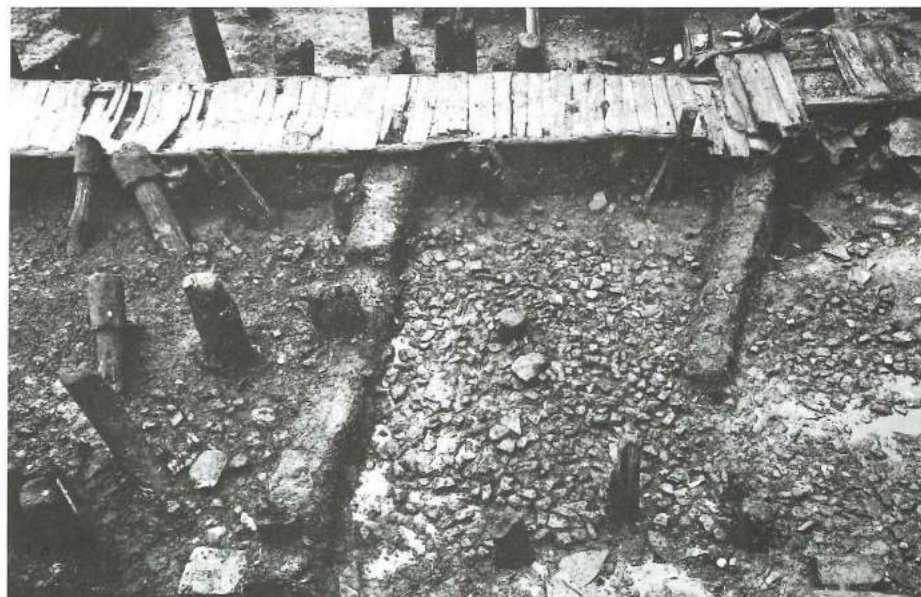
Fig 40 The passage between Rows 1 and 2 supported on upright posts, and the foundation posts of Building 478 in Row 1 capped with cylindrical crowns. Phase 3.1. Looking north.

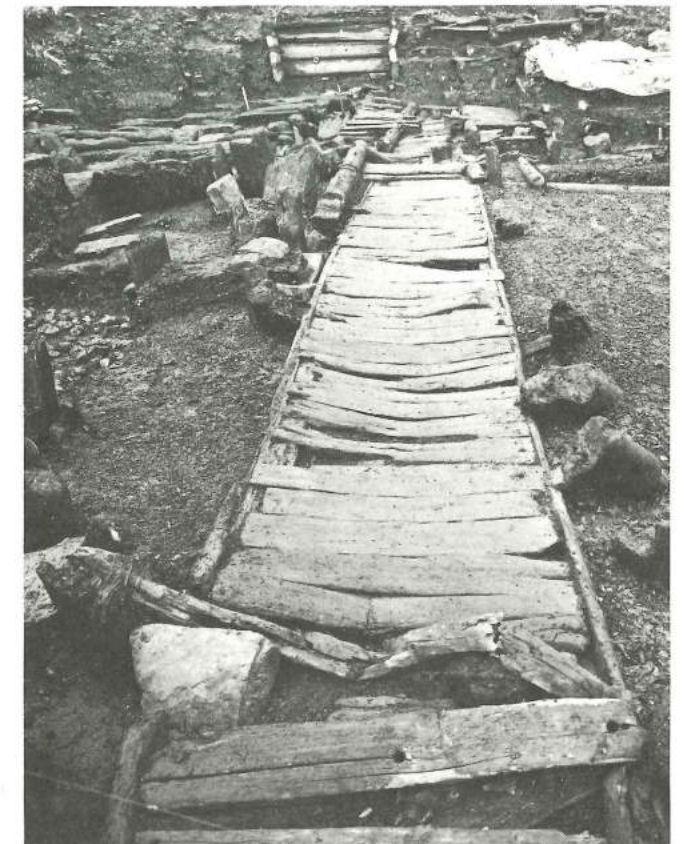
Fig 41 Section of the passage between Rows 1 and 2 in Phase 3.1 supported on upright posts. Looking east.

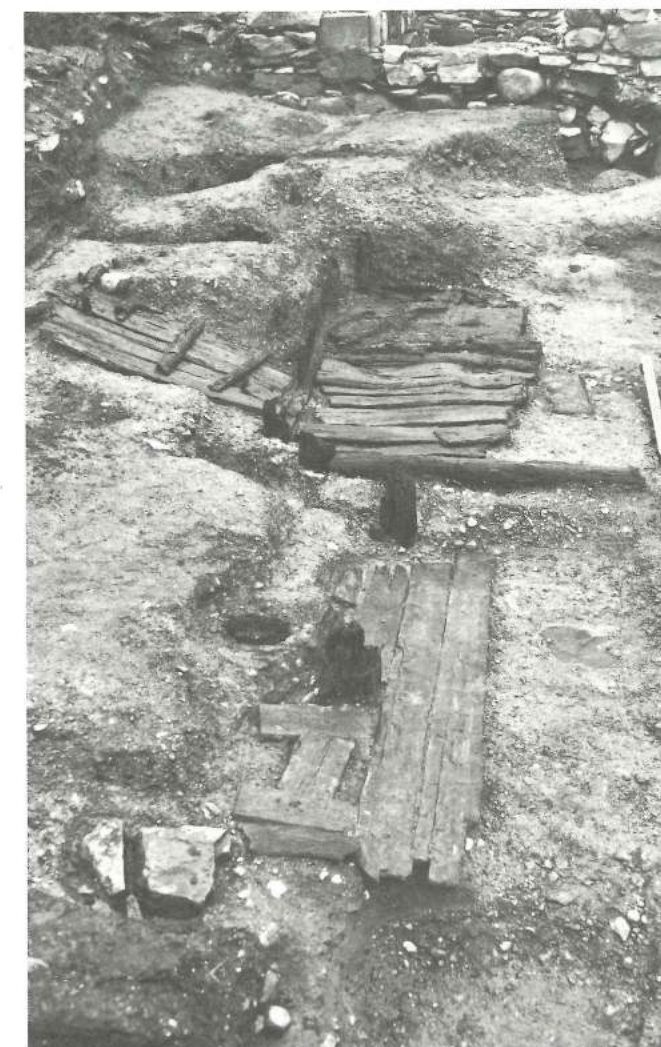
Fig 44 Side view of steps leading down from the passage to Building 66 in Phase 2.2. Looking east. (Cf next illustration.)

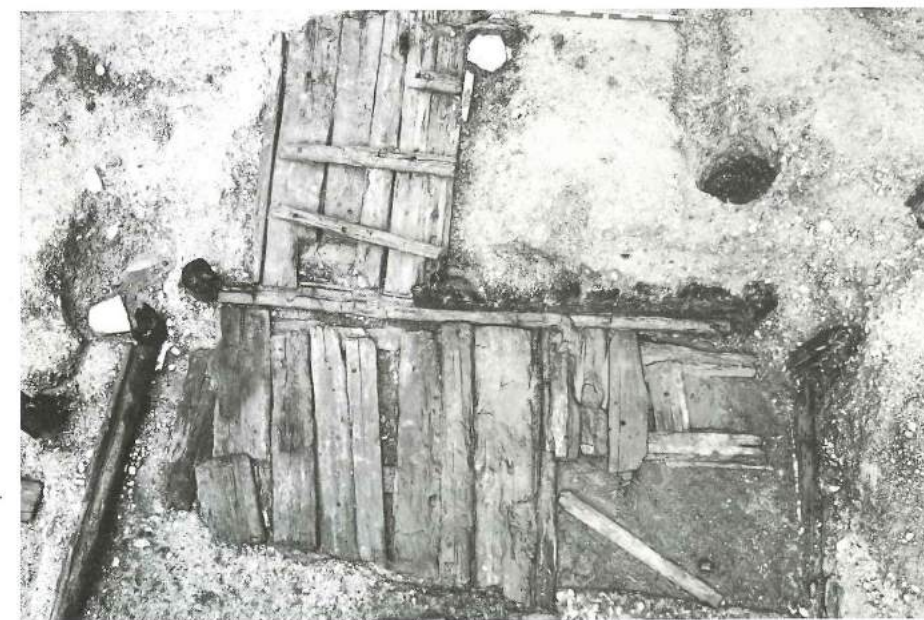
Fig 45 Front view of the steps between the passage and Building 66 in Phase 2.2. (Cf previous illustration.)

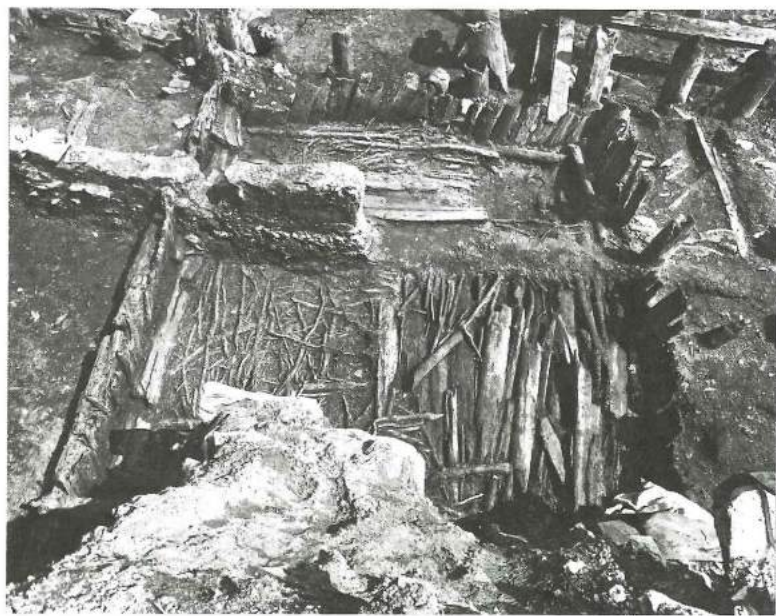
Fig 46 Building 38, with a vertical plank wall enclosing the area beneath the floor to form a cellar. The bottom of the cellar was covered with an "insulating" layer of old planks and branches. Burnt in Fire II (1170/71). Looking south.

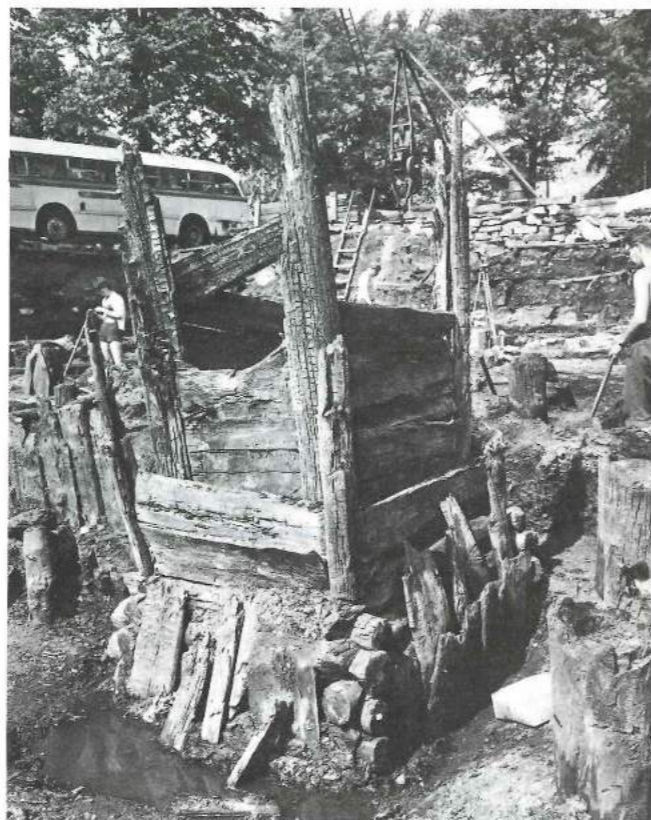
Fig 47 The various linings of the composite Well 5/4/2. The primary Well 5 was log-built, the next Well 4 was revetted with horizontal boards slotted into upright corner posts; the innermost and youngest Well 2 was of similar construction. Wells 2 and 4 may be part of one and the same well. Seen from the south-west.

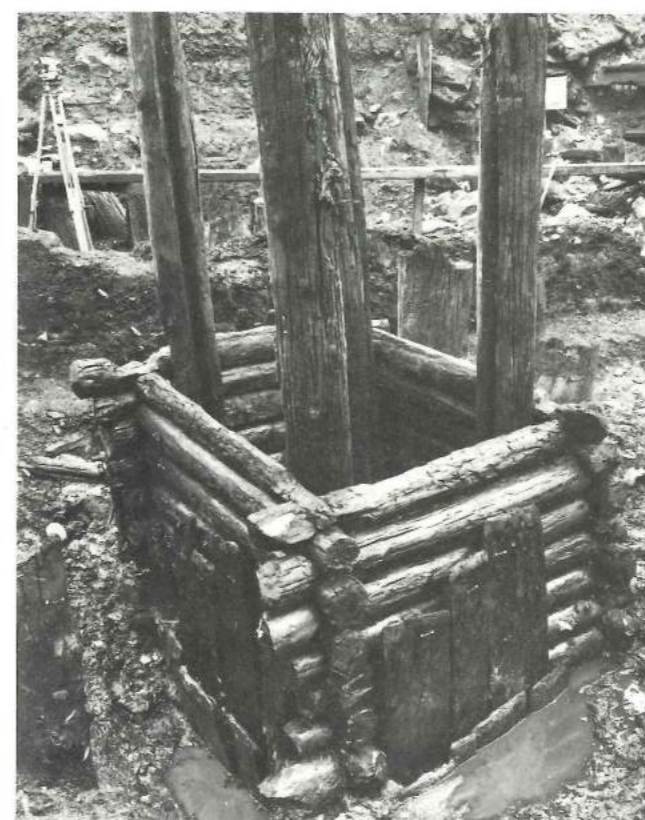
Fig 48 The corner posts of Well 4 inside the log frame of Well 5. Seen from the south-west.

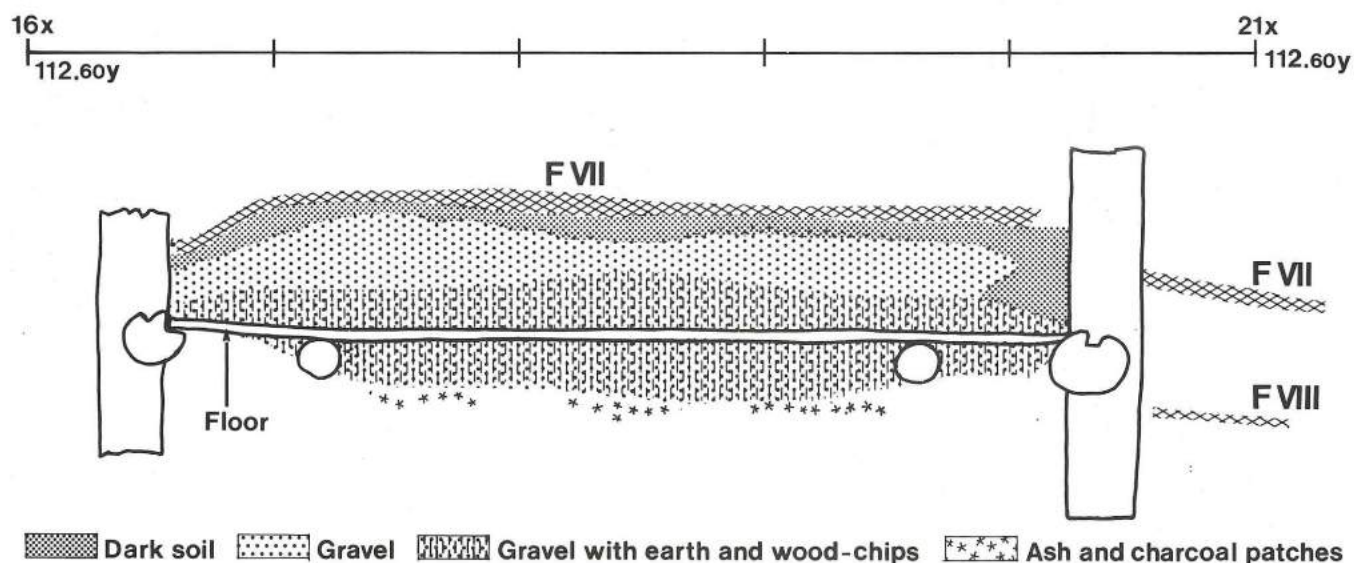
Fig 51 Cross-section through Building 45, looking east.

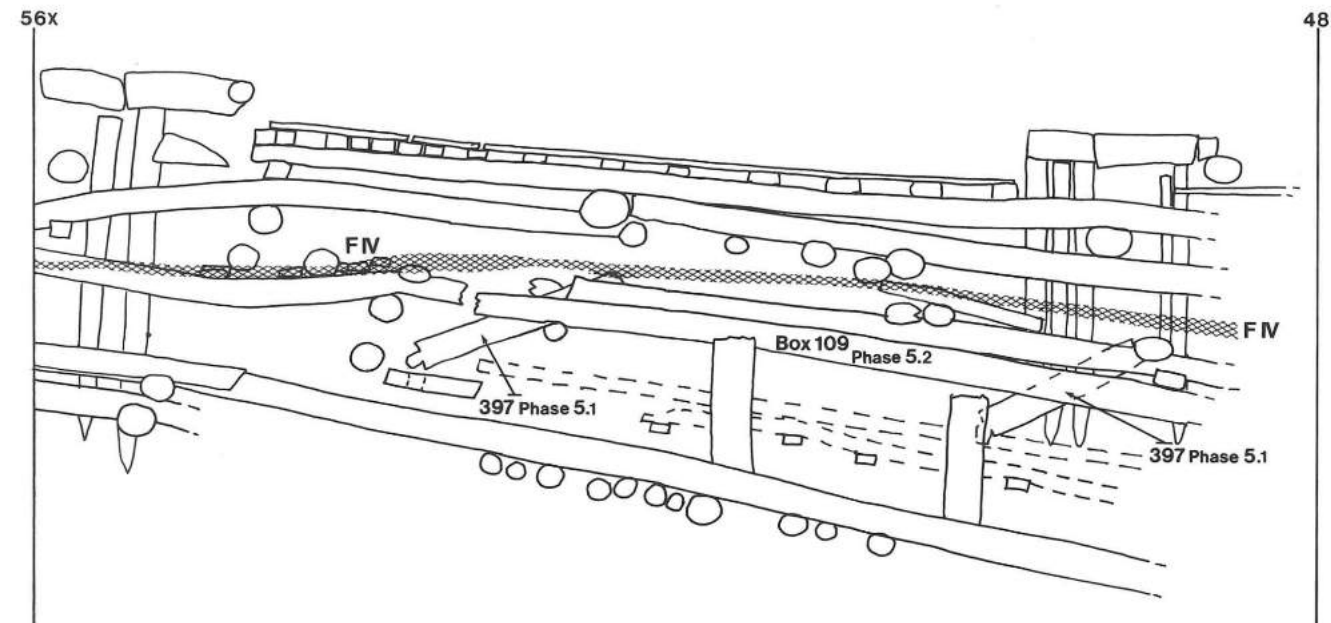
Fig 52 Part of long-section 85 through Søstergården South, showing the posts supporting Building 397 in the unburnt level over Fire V but secondarily burnt in Fire IV. Looking south.

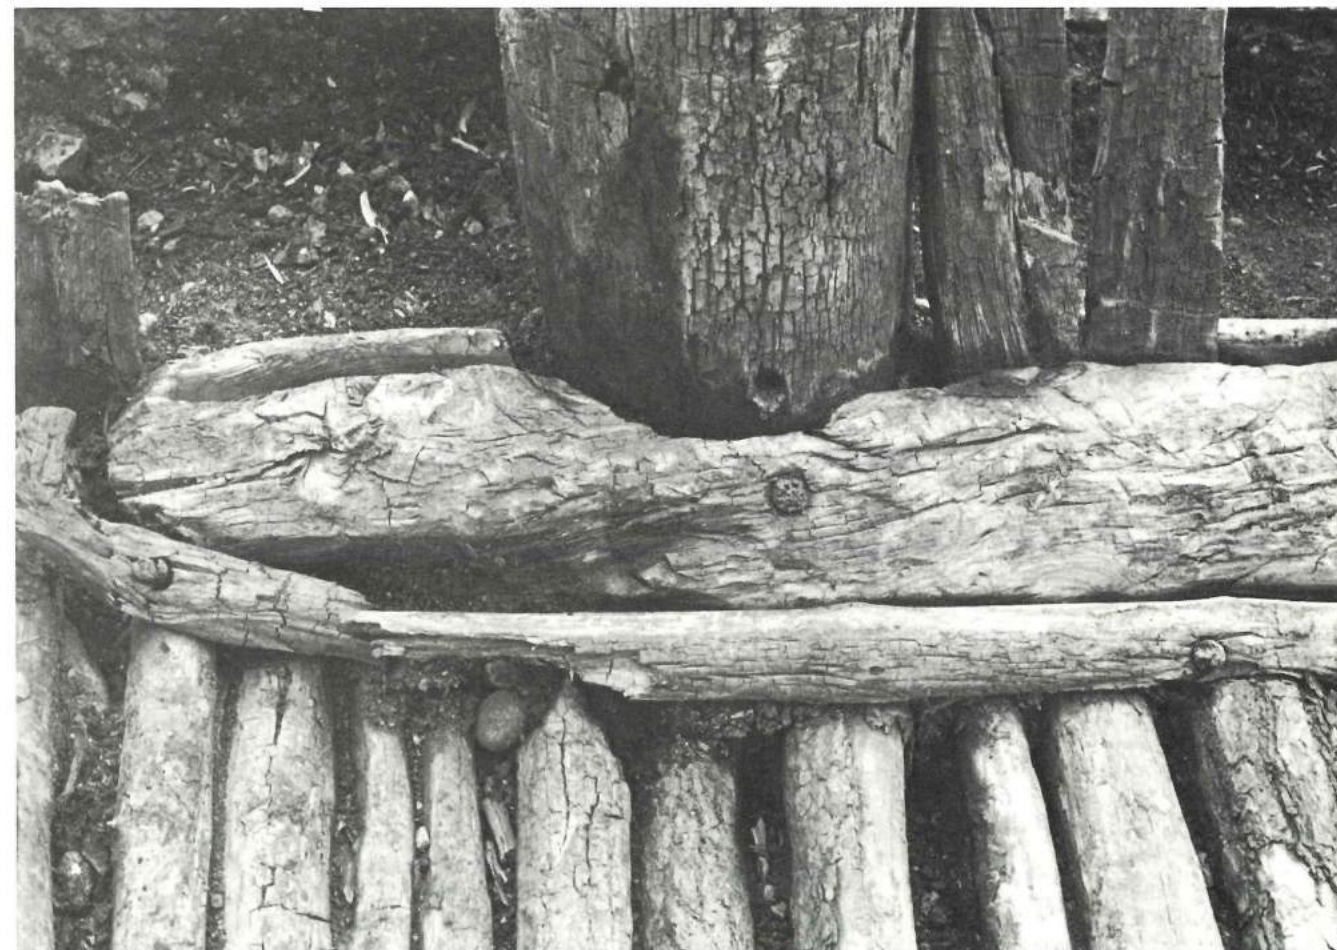
Fig 53 The third post from the west in the south wall of Building 45 with a hole for the wooden nail which can still be seen in the sill-beam, now lying below its original position. Looking south.

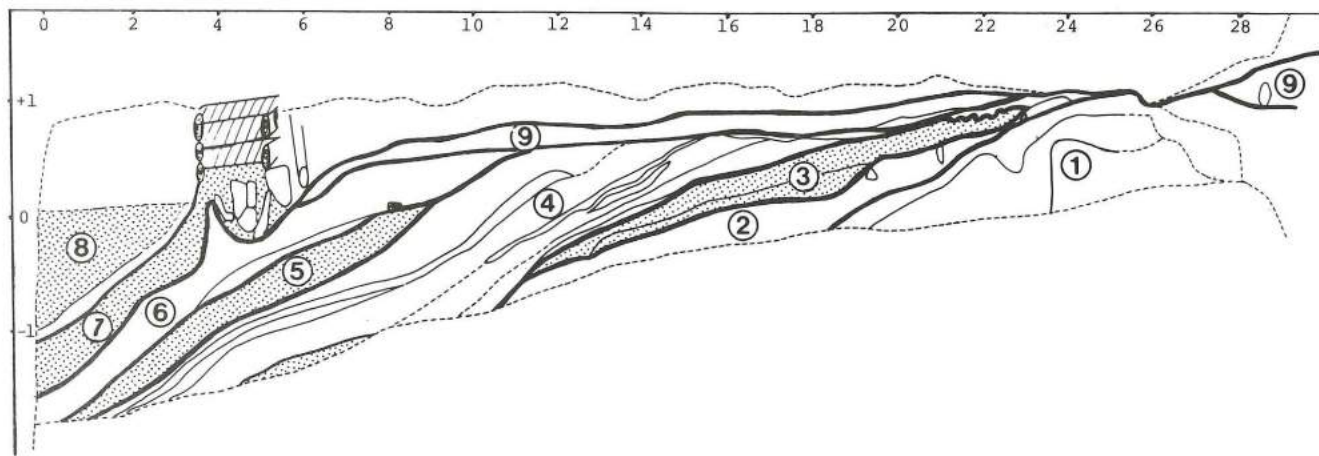
Fig 56 The stratigraphical sequence of the deposits revealed after building work began on the site. Looking north. Layers 3, 5 and 7 are organic deposits indicating early occupation. (After Krzywinski 1984.)

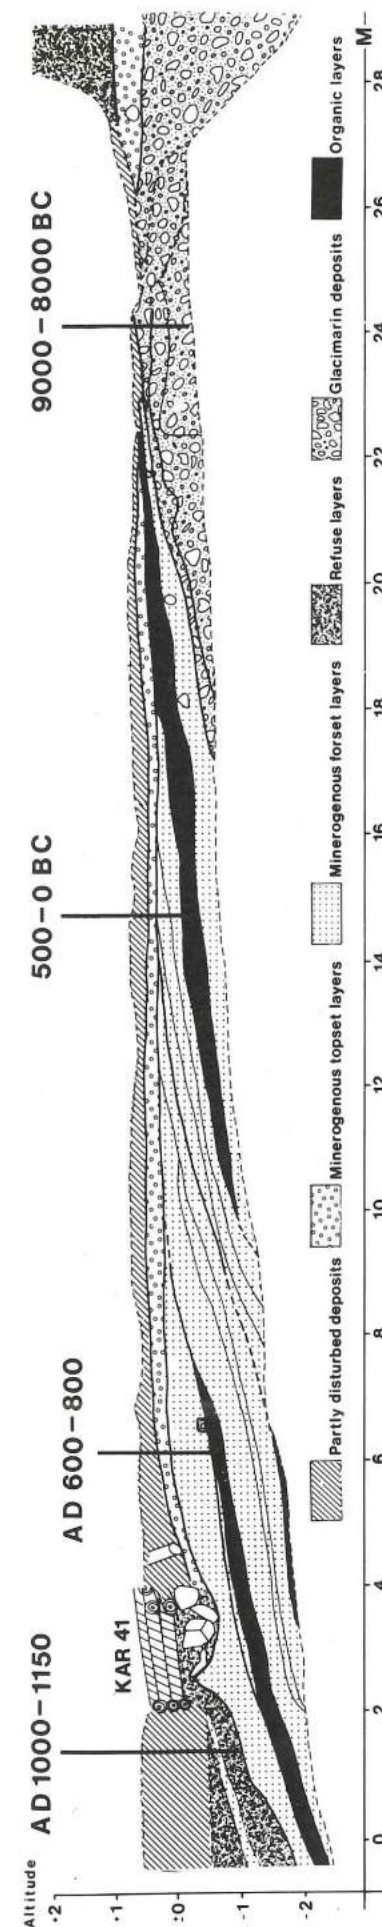
Fig 57 The radiocarbon dates of the most important layers in the section shown in fig 56. (After Krzywinski 1984.)
